**AN INTEGRATED APPROACH TOWARDS
THE CONSERVATION OF HISTORICAL SITES**

*Thesis submitted to the
Faculty of Engineering,
Ain Shams University, in Fulfilment
Of the Requirements for the Degree
of Master in Architecture*

Cairo
(1991)

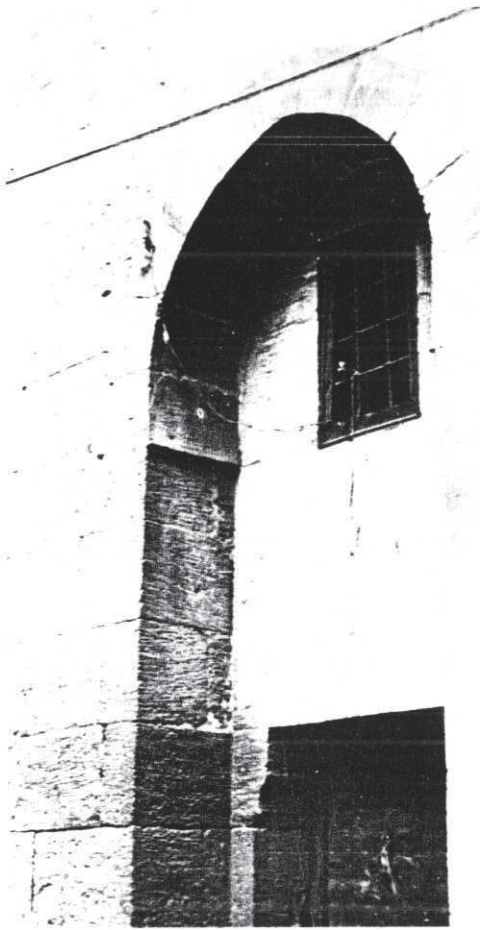
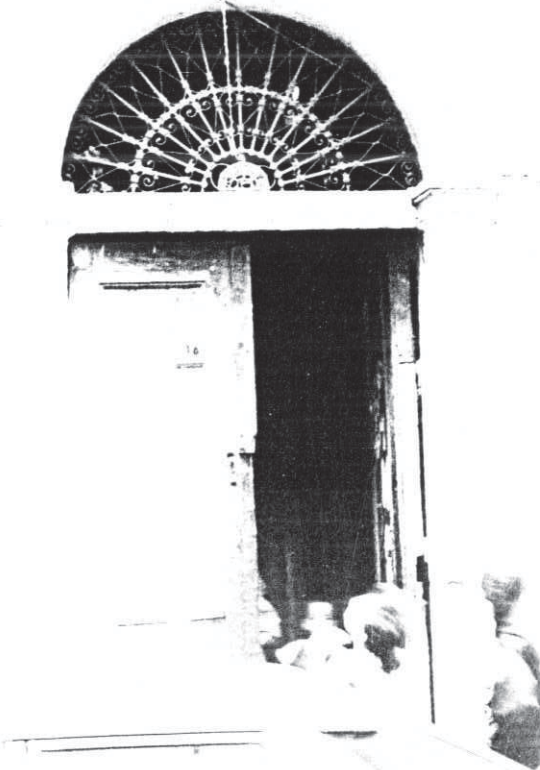
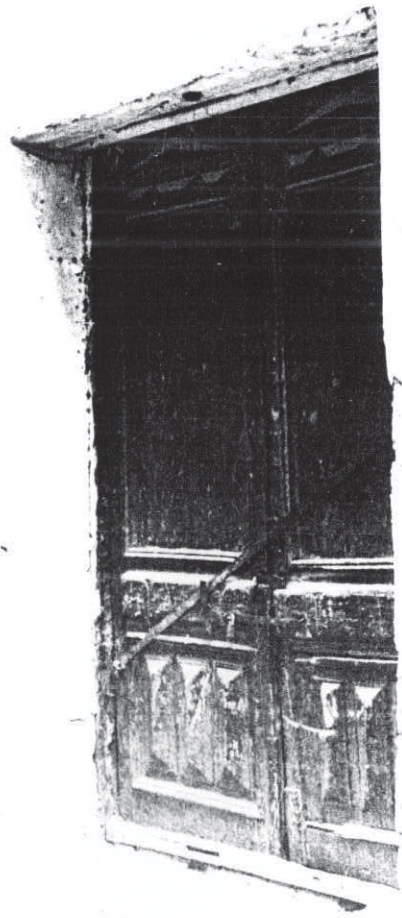
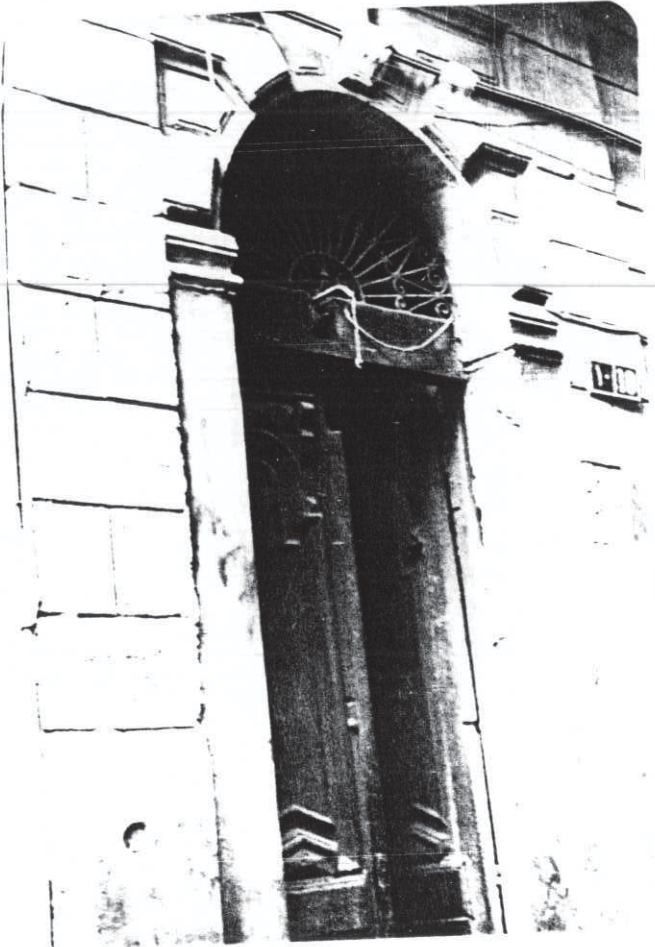
Fig. (35): Variety of windows and doorways from the study area. Their styles vary from pure geometrical to more ornamental designs.

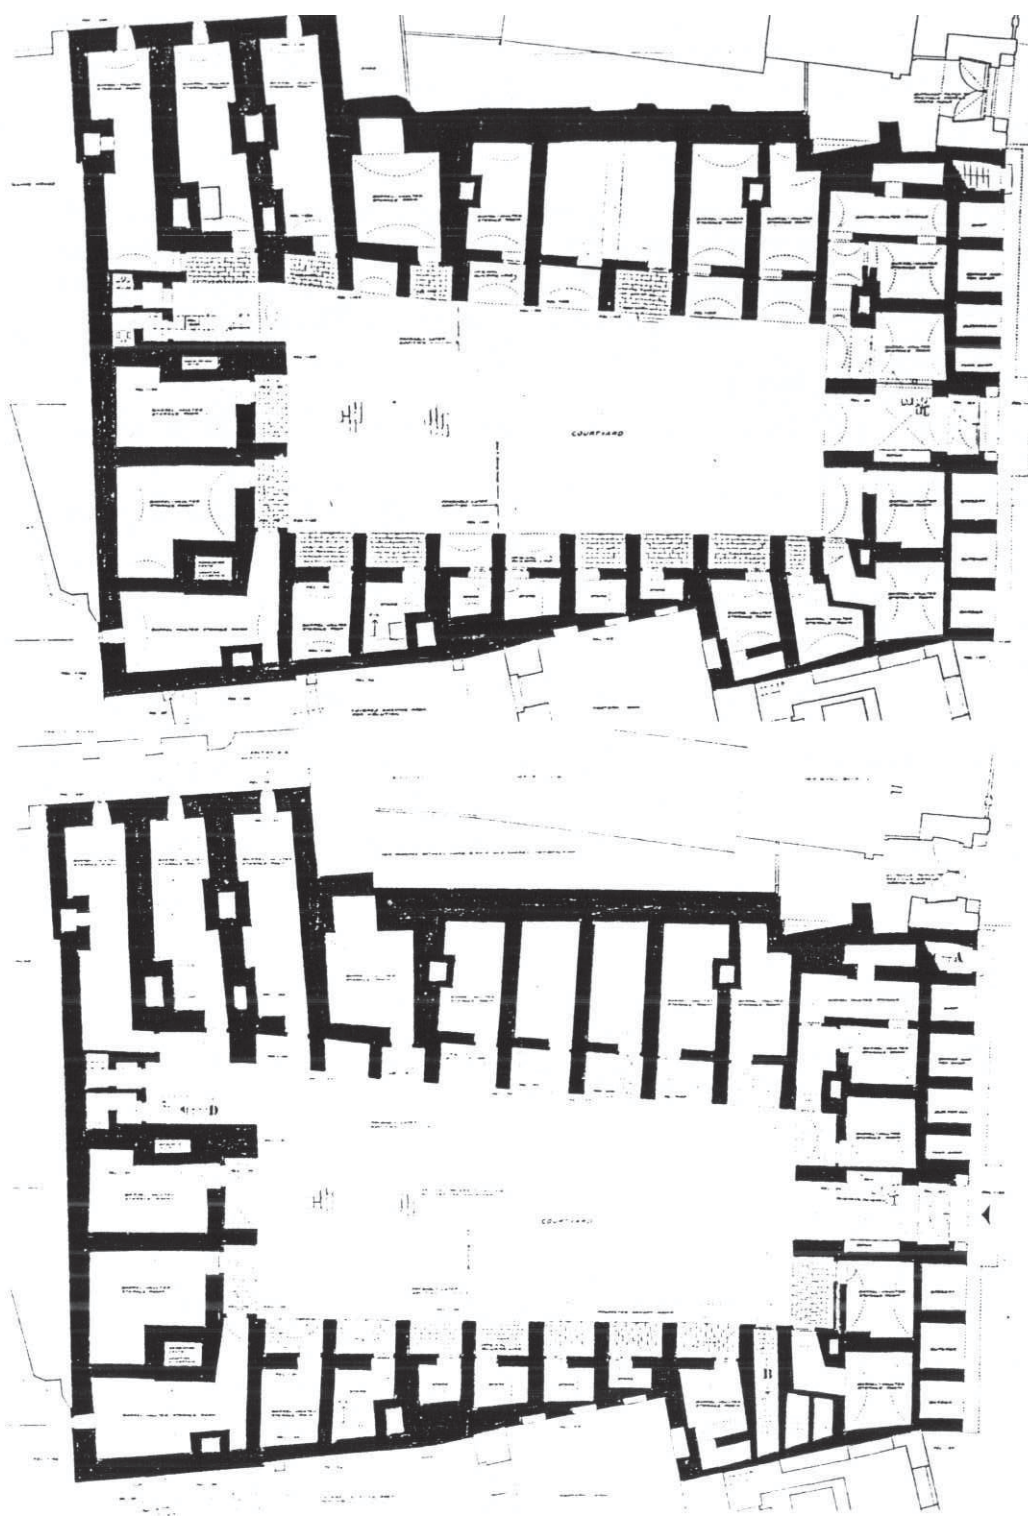
The examination of the whole structure revealed that the building is in a poor condition, although the upper storeys are preserved in full height. After the building was abandoned in 1974, all loose parts were carried away, the mashrabiya's are now ruined and the empty window openings reveal advanced decay. The appearance of the building has been spoilt by temporary wooden shelters filling up the courtyard. In the northern wing of the building towards the street an excessive vertical load has caused cracks and the facing of dressed limestone has been pushed out from the core of the wall in several parts. Above the entrance gate an iron beam has been inserted to take the load off the tier of beams at the second floor. The walls of the three upper storeys constructed in burnt bricks get thinner in keeping with the decrease of the thrust load.

Fig. (45)*: Wakalat Bazaraa, plan of the ground floor, present condition and proposal for restoration.

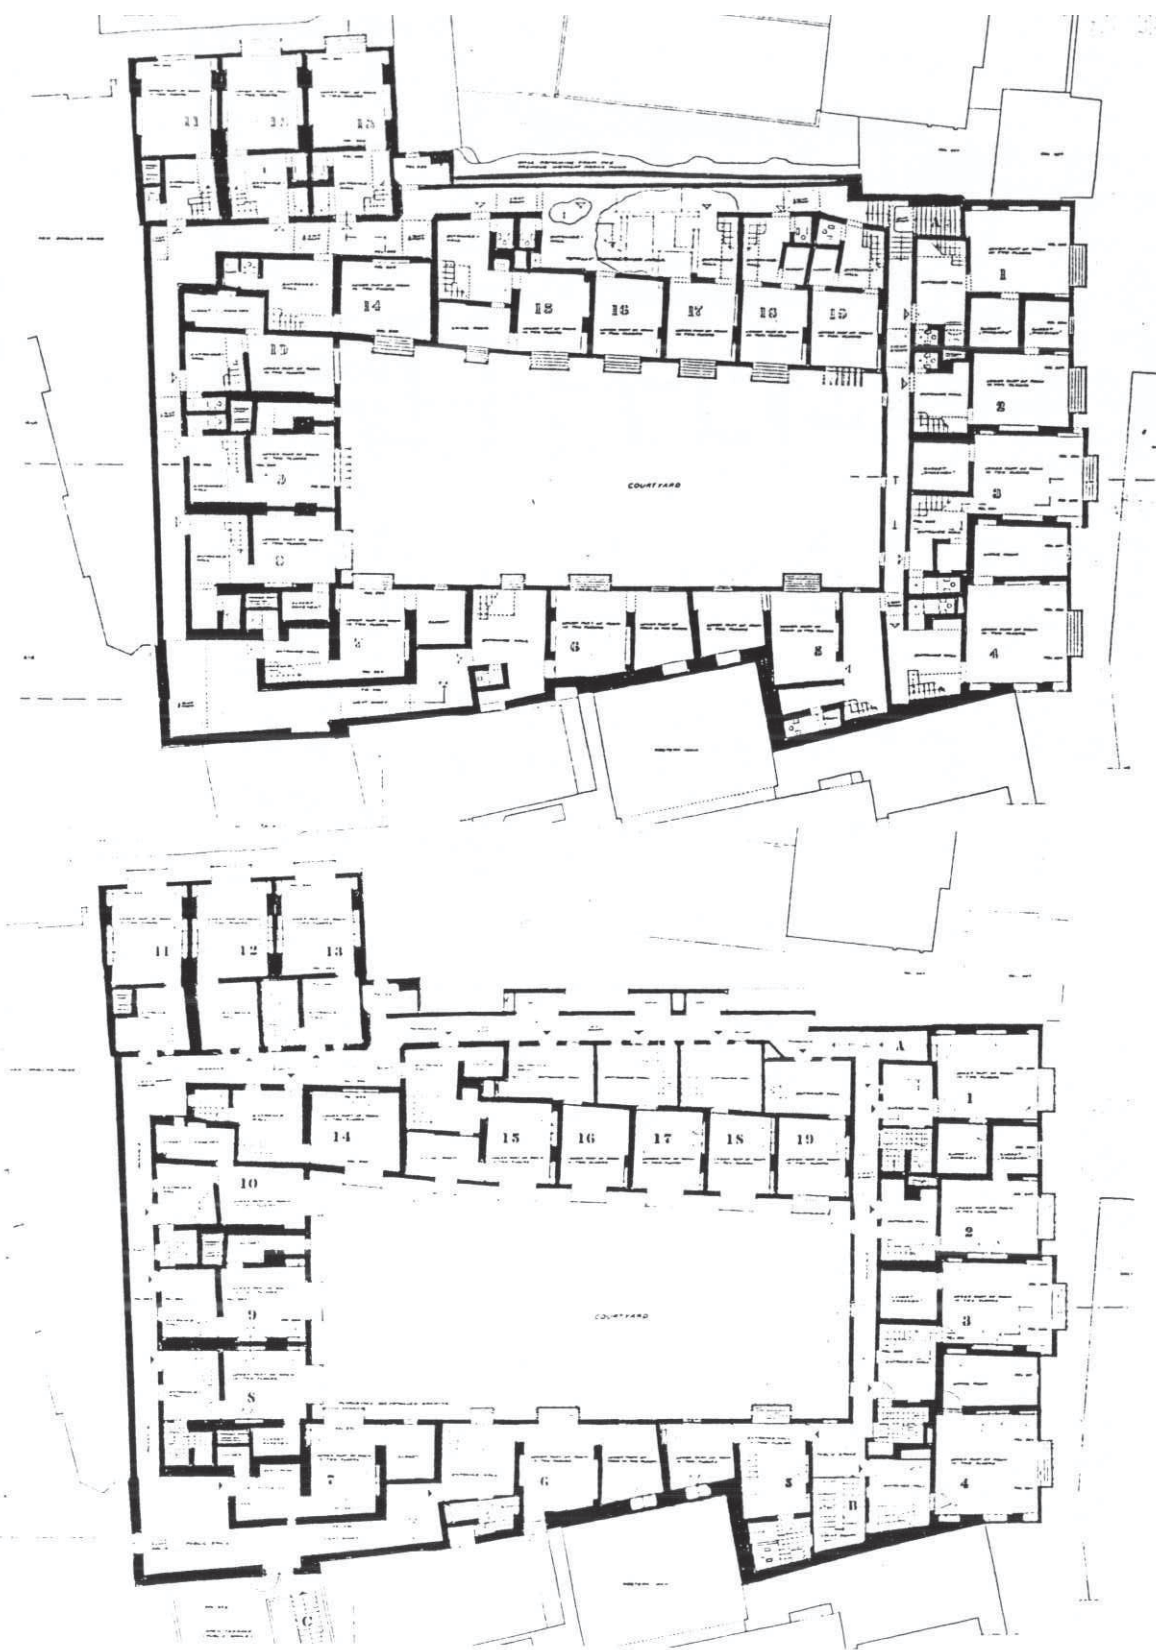
Fig. (47)*: Wakalat Bazaraa, Plan of the second floor, present condition and proposal for restoration.

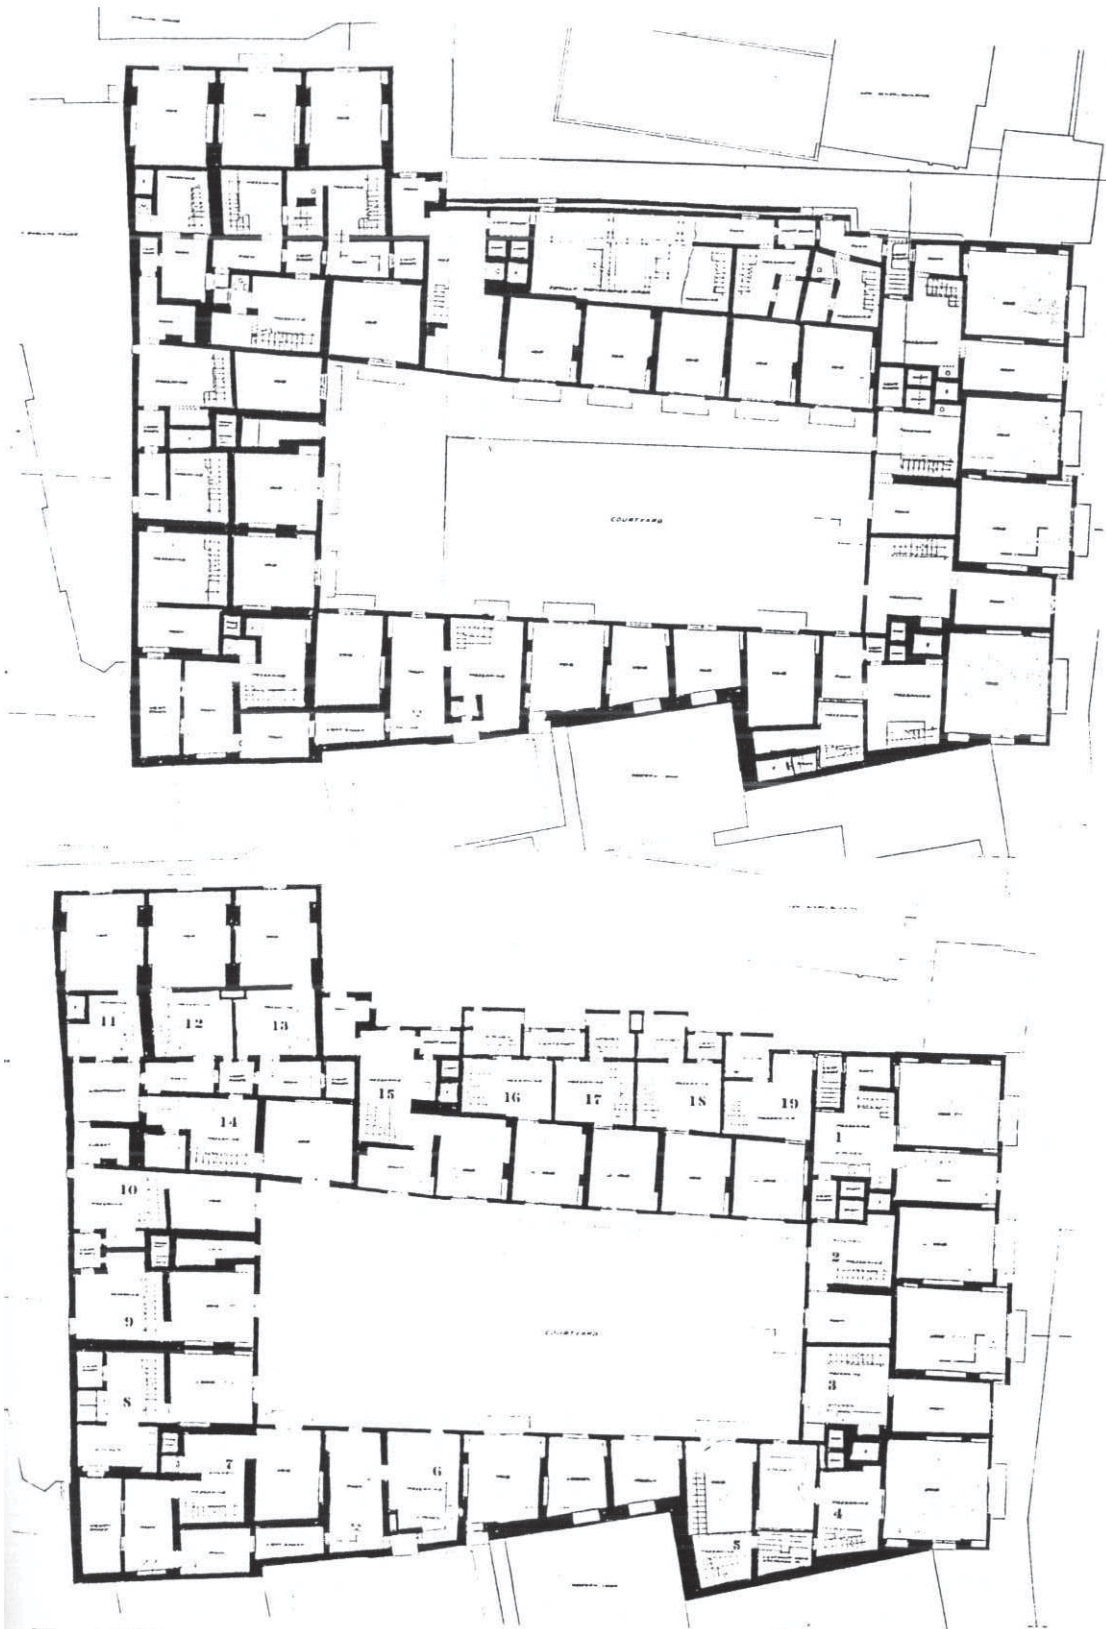
Fig. (48)*: Wakalat Bazaraa, plan of the third floor, present condition and proposal for restoration.

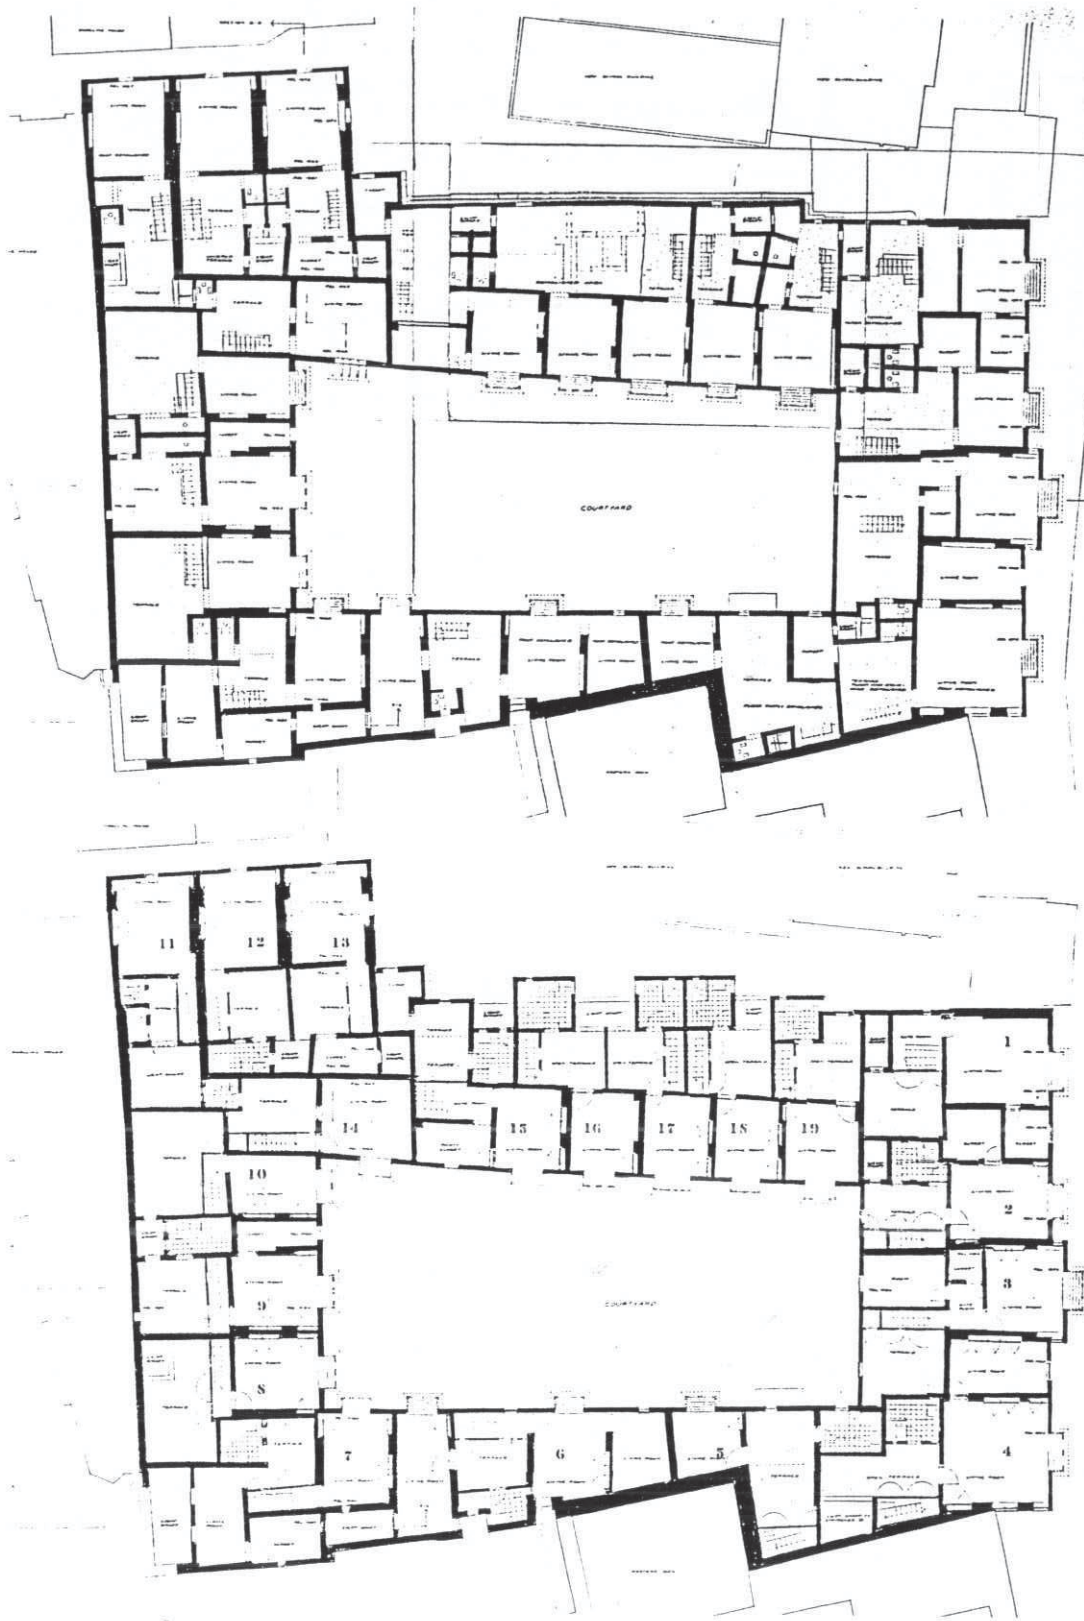
Fig. (49)*: Wakalat Bazaraa, plan of the fourth floor, present condition and proposal for restoration.

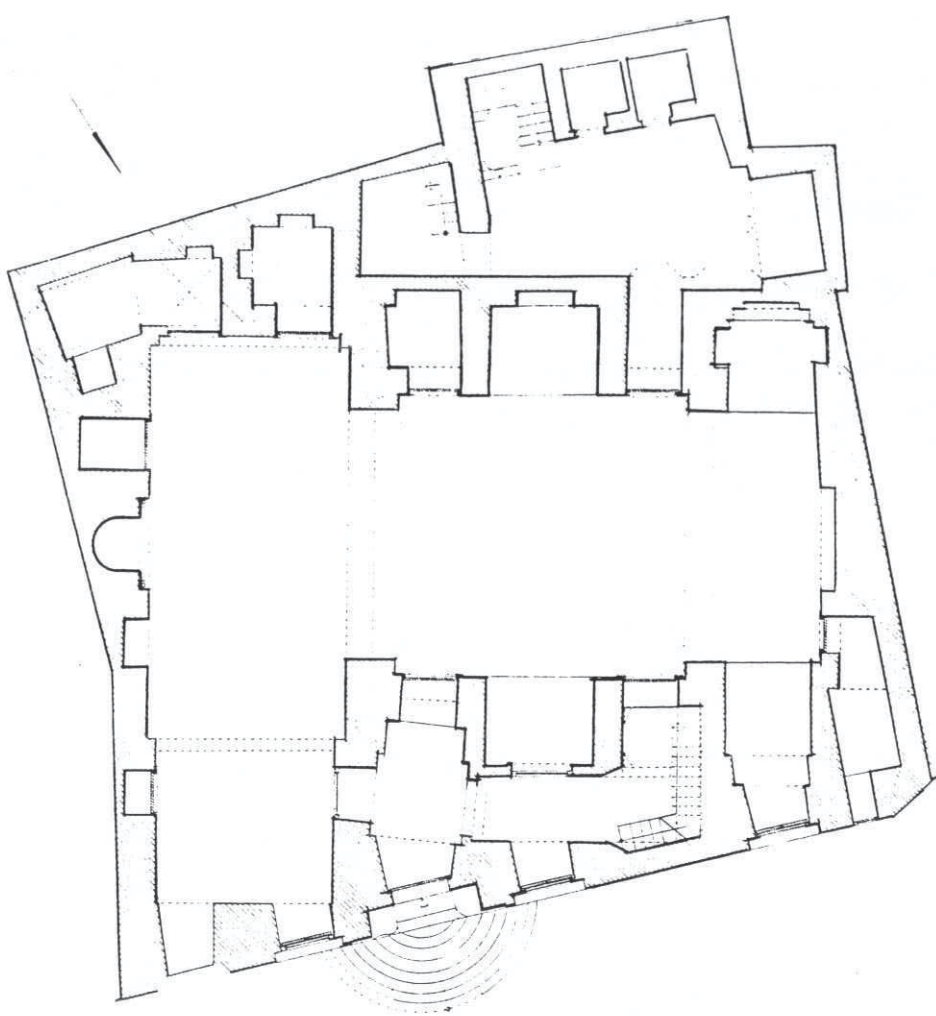
Before restoration in 1973

Drawings showing the existing condition and structural state were prepared before the actual work began. The original plan was reconstructed along the lines of the ruined remains. The remaining parts of the building's fabric were secured and the missing portions totally rebuilt. Rooms in the northern and southern sides, toilets and staircases were reconstructed. A great deal of the stonework destroyed by saline corrosion, especially on the lower part of the walls, had to be exchanged. Care was taken to use the traditional methods still practiced in Cairo, and local craftsmen for the conservation and completion of the architectural decoration. Those craftsmen included stone cutters, experts in gypsum and carpenters. The stone mosaic and the marble of the qibla-iwan: which had been partly destroyed by saline corrosion, were replaced. Other decorative details like the arabesque panels and the blue glass columns of the arcaded horizontal frieze were completed. The lost crenellations that had topped the walls surrounding the inner courtyard were renewed. The plaster work and the glass lattice windows which had been filled in from behind were cleared and pieced out. The painted and partly, carved woodwork was carefully cleaned, then chemically strengthened and restored. A new marble floor was laid, its

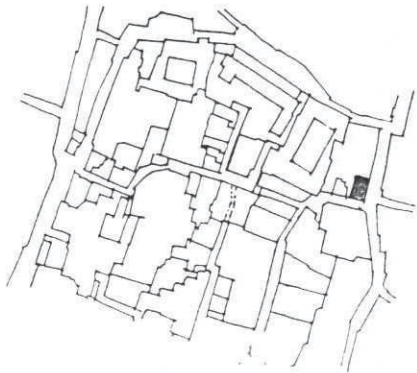
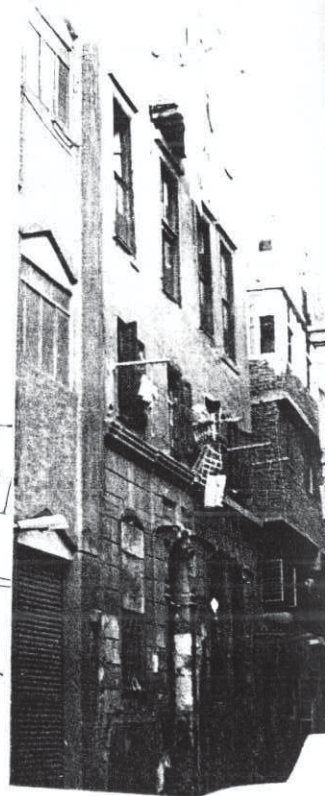
Fig. (58)
Buildings built since 100 years ago
till the fifties are still intact and
in need of slight repairs and
alternations

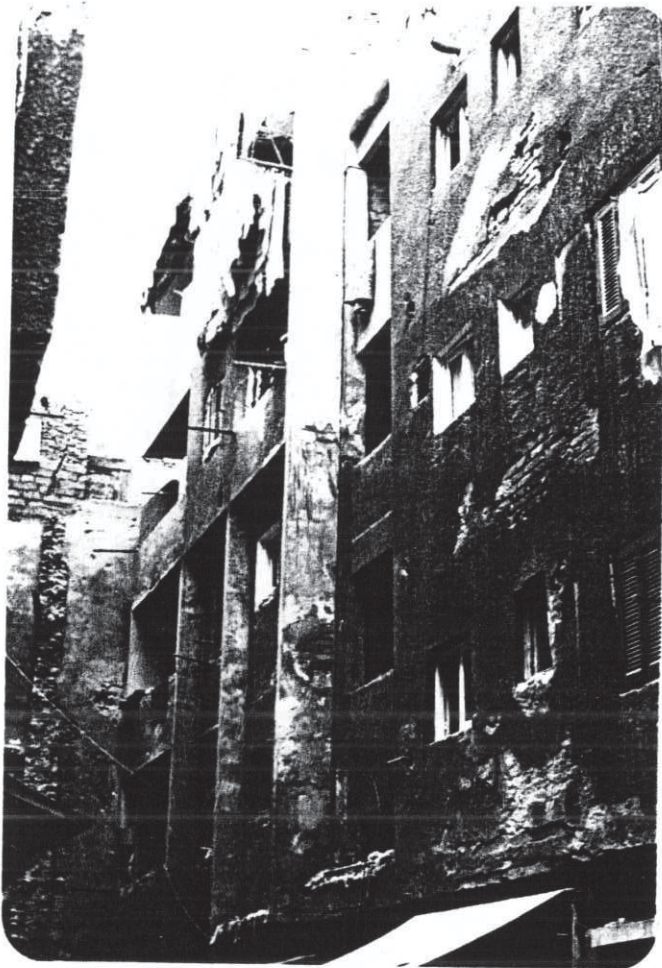
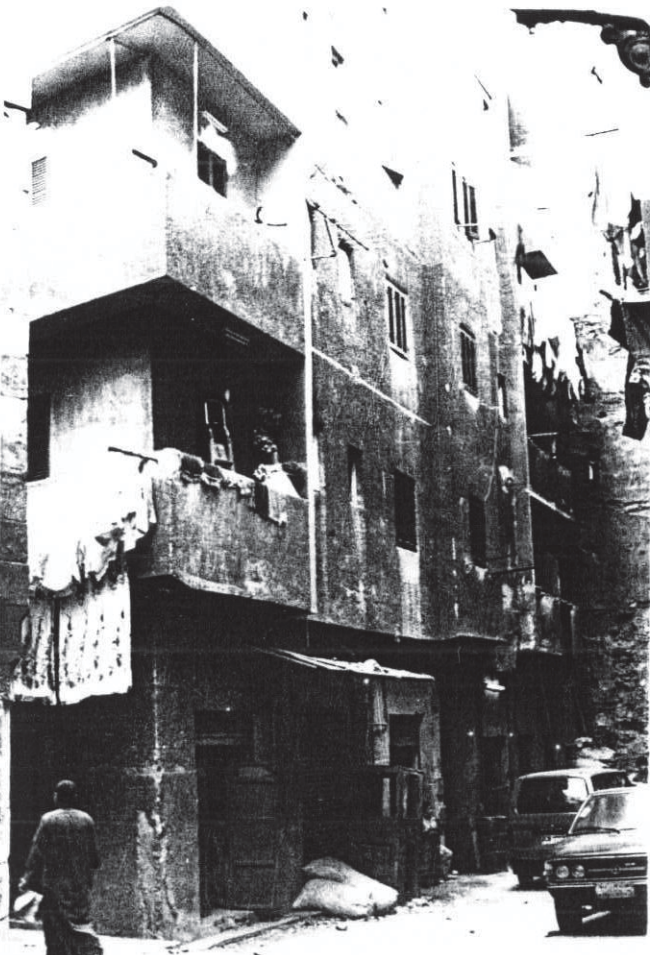
Fig. (59): Buildings built after the 60s are in bad repair and not in agreement with the historical environment.

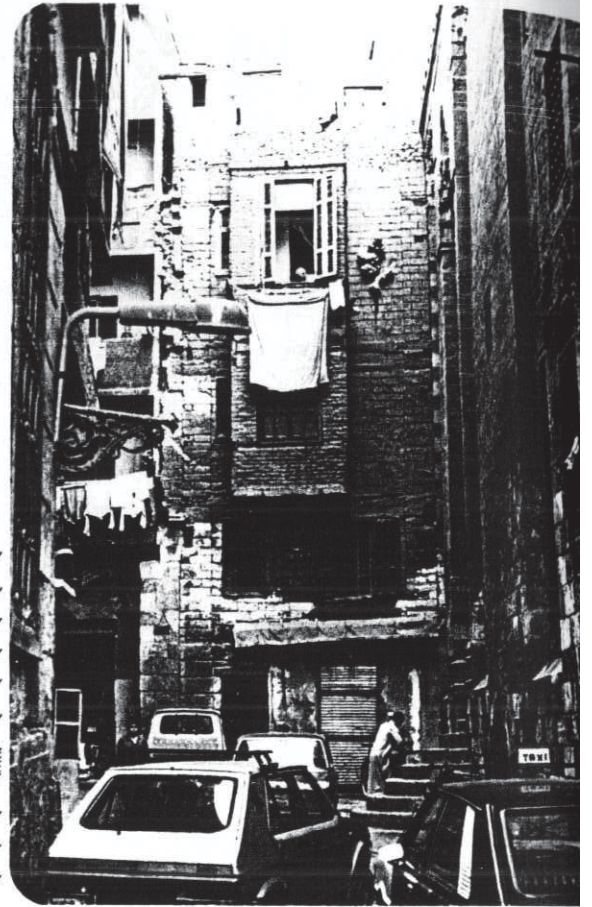
House no. 21 in Darb-Qirmiz.

Fig. (60): Present condition

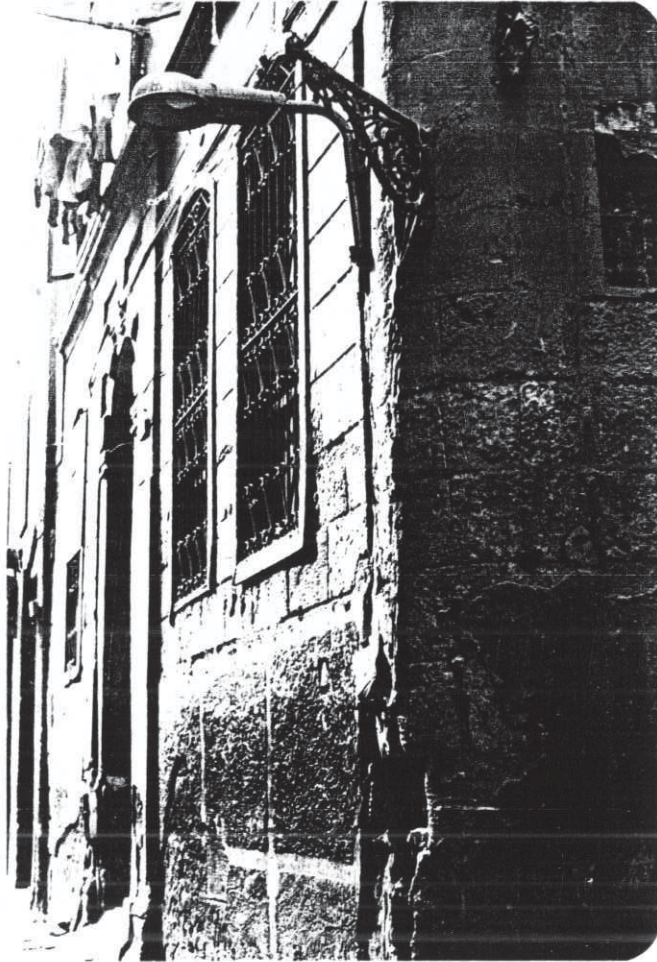
Fig. (64): Light installations which were once a piece of art were replaced by functional installations with no aesthetic value.
