Towards a Sustainable Development for improving safety of Building during wars –Gaza Strip as a Case Study

Author name: **Dr. Eng Usama I. Badawy**, Technical University of Berlin, Germany, E-mail: ubadawy@web.de ,u.badawi@unrwa.org

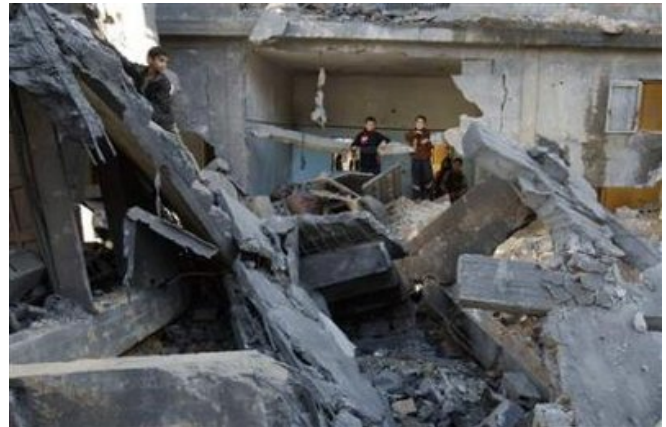
Figure 2: photo of totally damaged housing units.

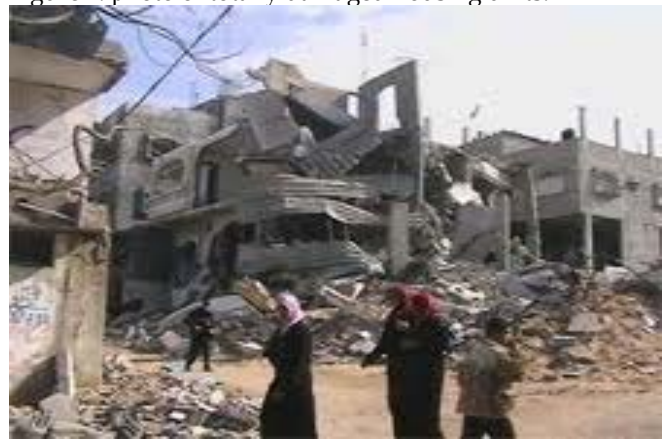
Figure 3: photo of collapse of the building.

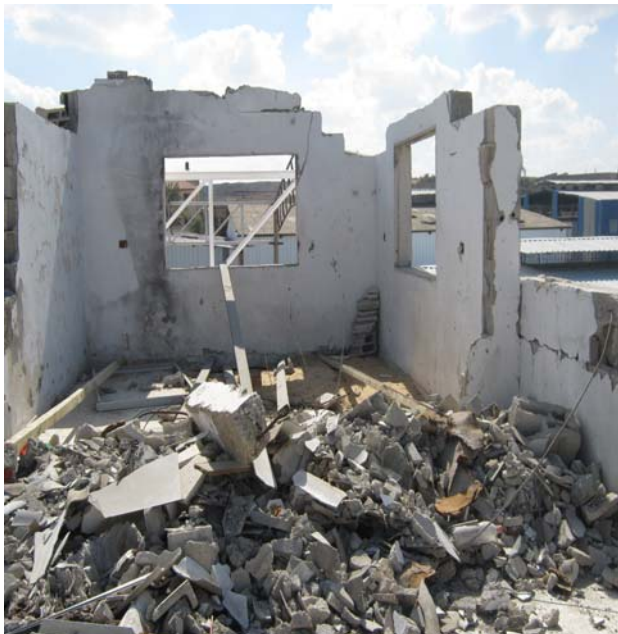
Figure 1: photo of localized failure of exterior walls, windows, roof system and columns.

Mostly the ground and the first floors of building were subjected to fire and serious damages which caused structural damages in the columns and floors .the damages in the buildings include the following: -Fire caused minor damages including spalling of plaster and black smoking as it was seen in

-Buckling of the concrete and reinforcement steel in some columns.

-Wide cracks and destruction in the walls.

-Damages to windows and breaking the glass and the aluminum frames.

-Spalling of the concrete cover in the some parts of the beams and columns.
