طرق تدعيم العناصر الخرسانية المسلحة

بحث تطبيقي مقدم من

للحصول على ماجستير الهندسة في الهندسة
المدنية

ABSTRACT

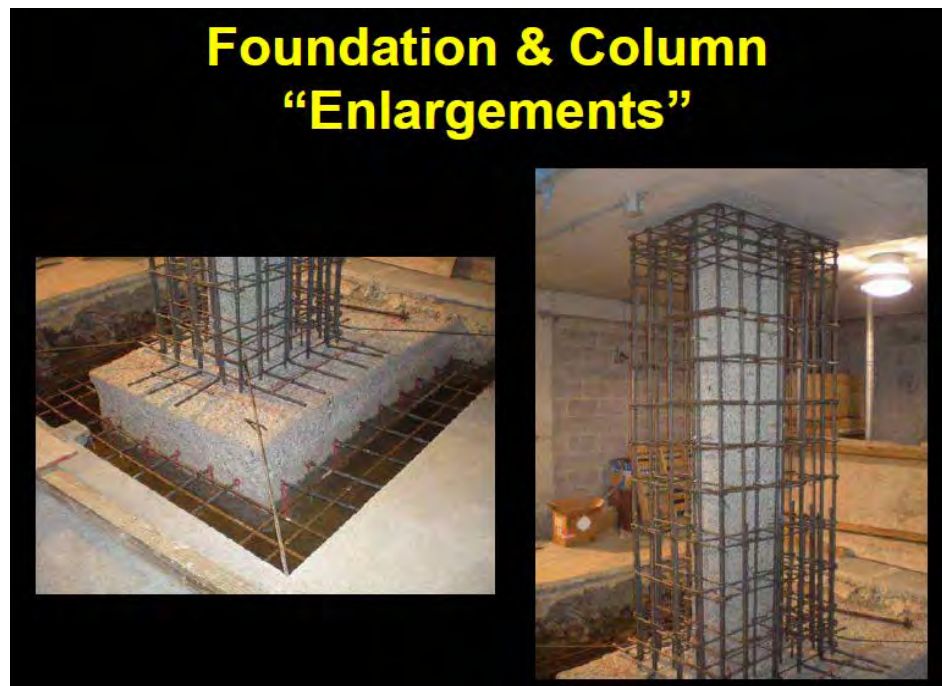
Columns foundations need strengthening in the case of applying additional loads. Widening and strengthening of existing foundations may be carried out by constructing a concrete jacket to the existing footings. The new jacket should be properly anchored to the existing footing and column neck in order to guarantee proper transfer of loads. The size of the "jacket" shall be selected such that the average maximum foundation pressure does not exceed the recommended allowable value. Attention shall be given during construction in order that the excavations for the new "jackets" do not affect the existing adjacent foundations.

Figure 3.1 Foundation and column strengthening by RC jacketing.

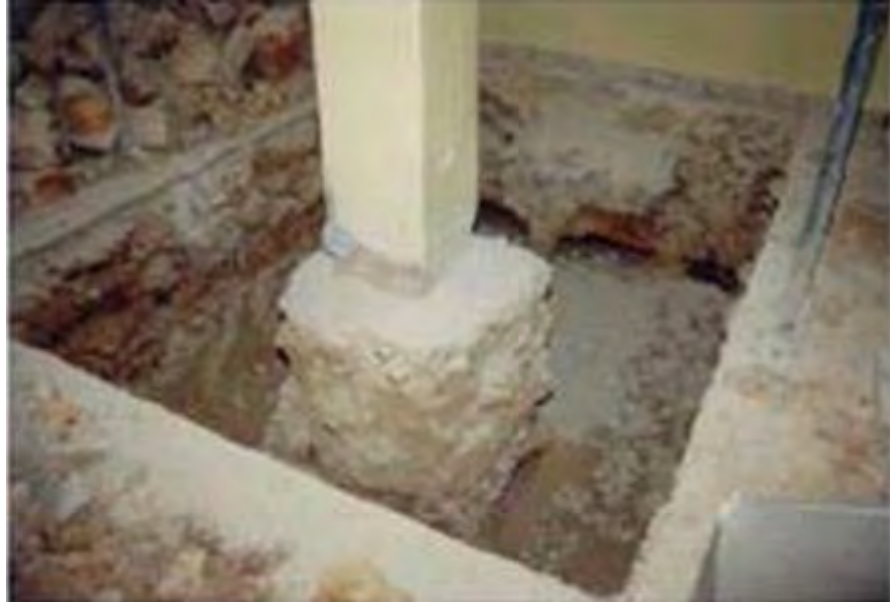
Figure 3.3 Excavation around the footing.

The following figures (3.3-3.6) illustrate the practical way of jacketing a footing by reinforced concrete.

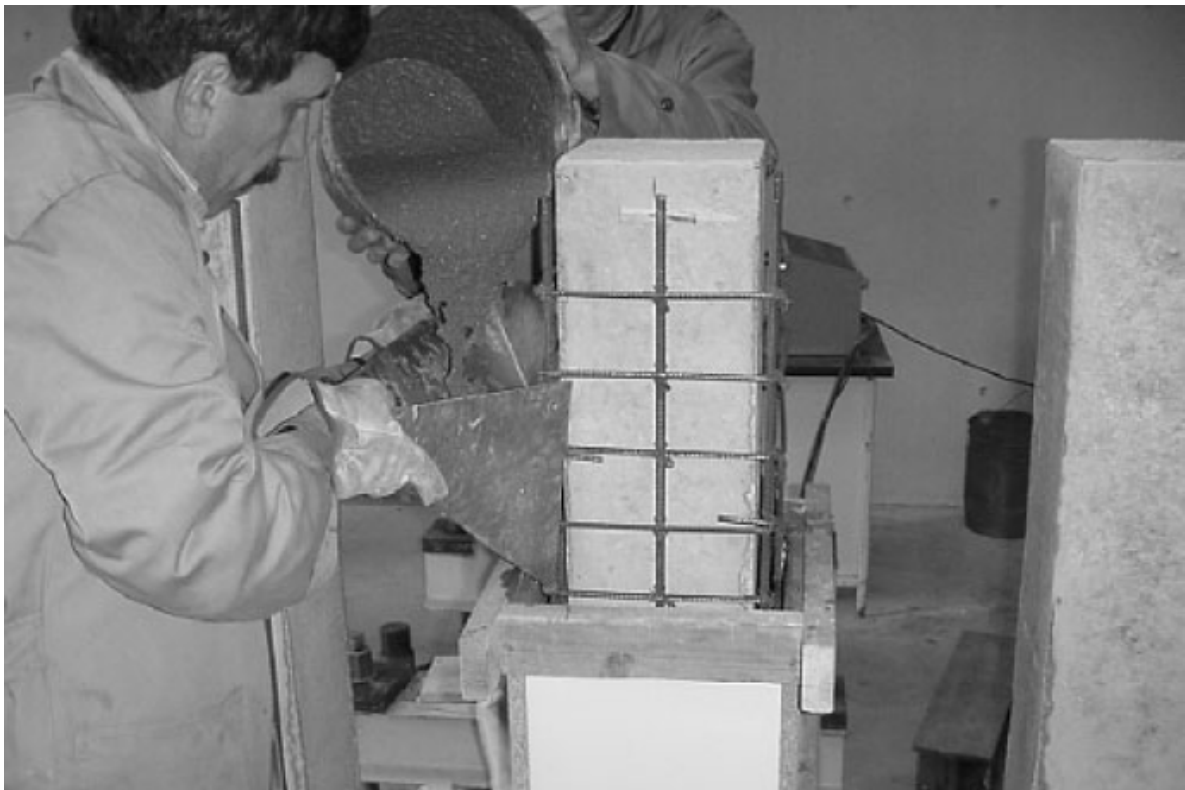
Section enlargement is one of the methods used in retrofitting concrete members. Enlargement is the placement of reinforced concrete jacket around the existing structural member to achieve the desired section properties and performance. The main disadvantages of such system are the increase in the column size obtained after the jacket is constructed and the need to construct a new formwork as shown in figure 4. 1.

Figure 4. 1. Increasing the cross-sectional area of column by RC jacketing.

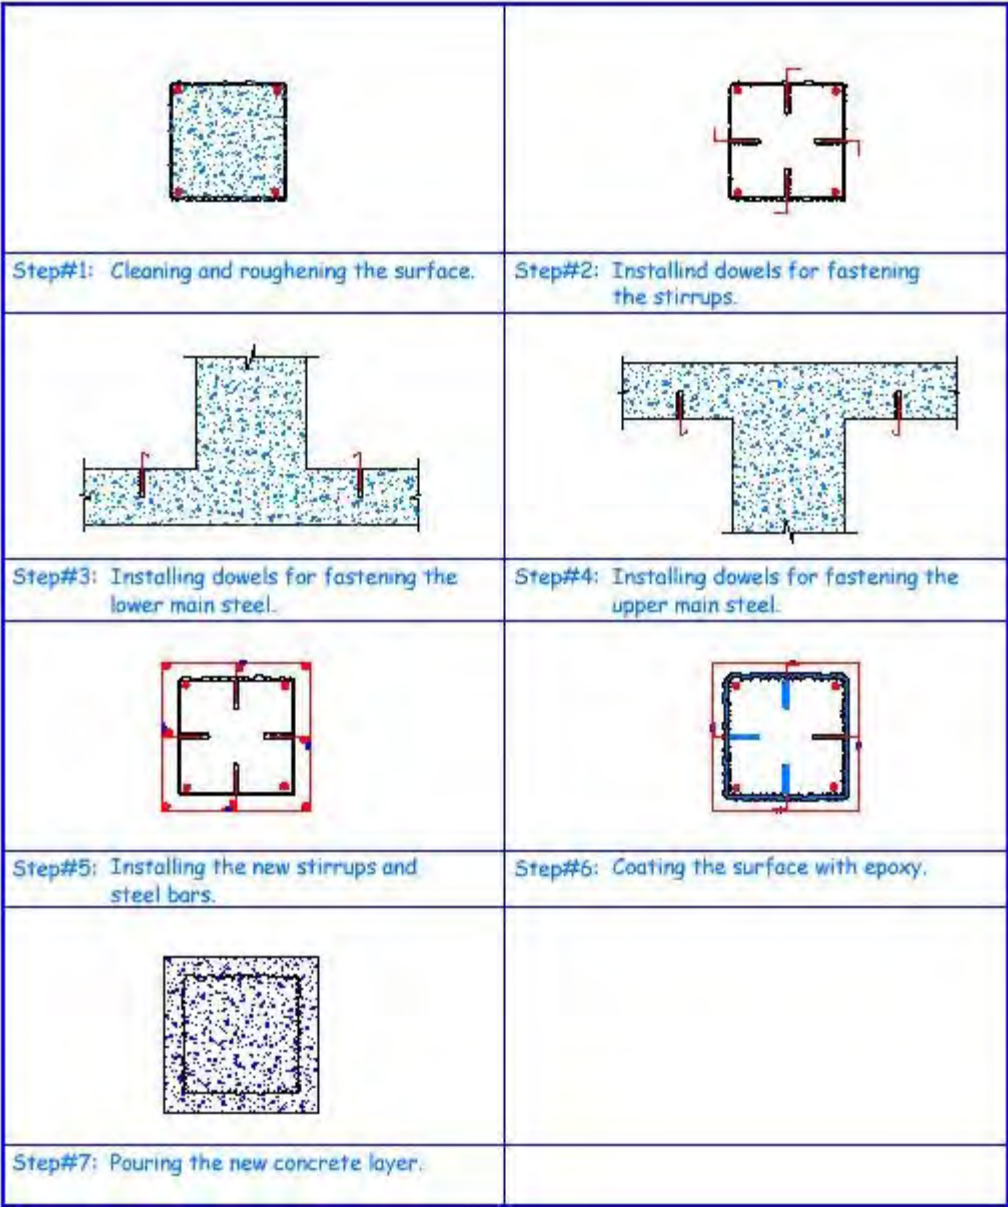
Figure 4. 2. Concrete jacketing steps.

The previous steps are illustrated in Figure 4. 2.

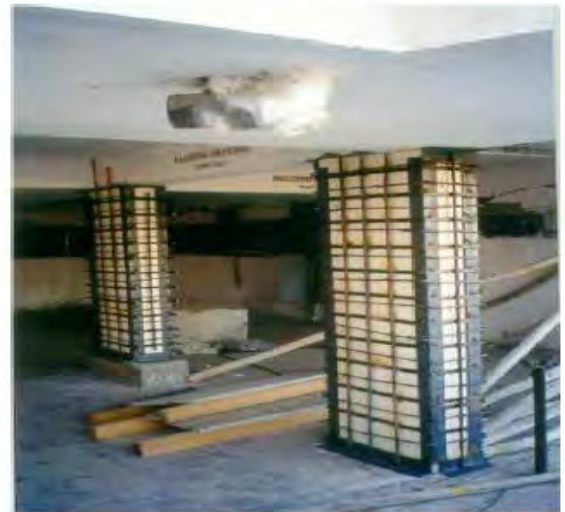
Confining reinforced concrete column in steel jackets is one of the effective methods to improve the earthquake resistant capacity. As compared with conventional hoops or spirals, steel jacket has two more remarkable advantages; 1) to easily provide a large amount of transverse steel, hence strong confinement to the compressed concrete, and 2) to prevent spalling off of the shell concrete. Spalling of the shell concrete may be considered as the main reason for deterioration of bond and buckling of longitudinal bars of columns and is hardly prevented by conventional hoops. Because of these advantages of the steel jacket, confining method utilizing steel jacket has been increasingly used to retrofit or strengthen the existing reinforced concrete columns without adequate detailing. This method is referred to as the steel jacket retrofit hereafter.

Figure 4. 5. Steel jacketing

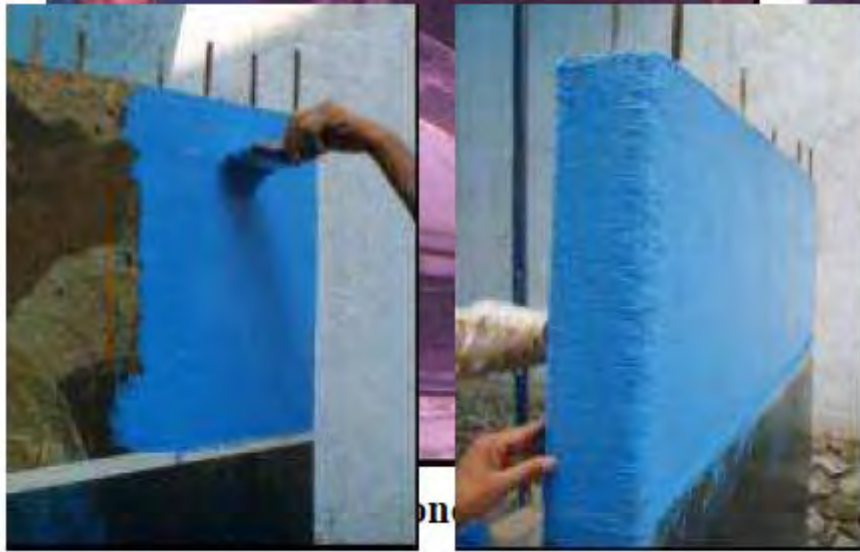
Application of Saturant

1. Surface preparation: This includes
 - a. Grinding to the column surface to remove dust and cement loose layer.
 - b. Repair of hairline cracks, if any.
 - c. Rounding off of column corners to specified rounding radius
 - d. Application of Primer
2. Once the surface is prepared and primer dried, the next step is application of saturant.

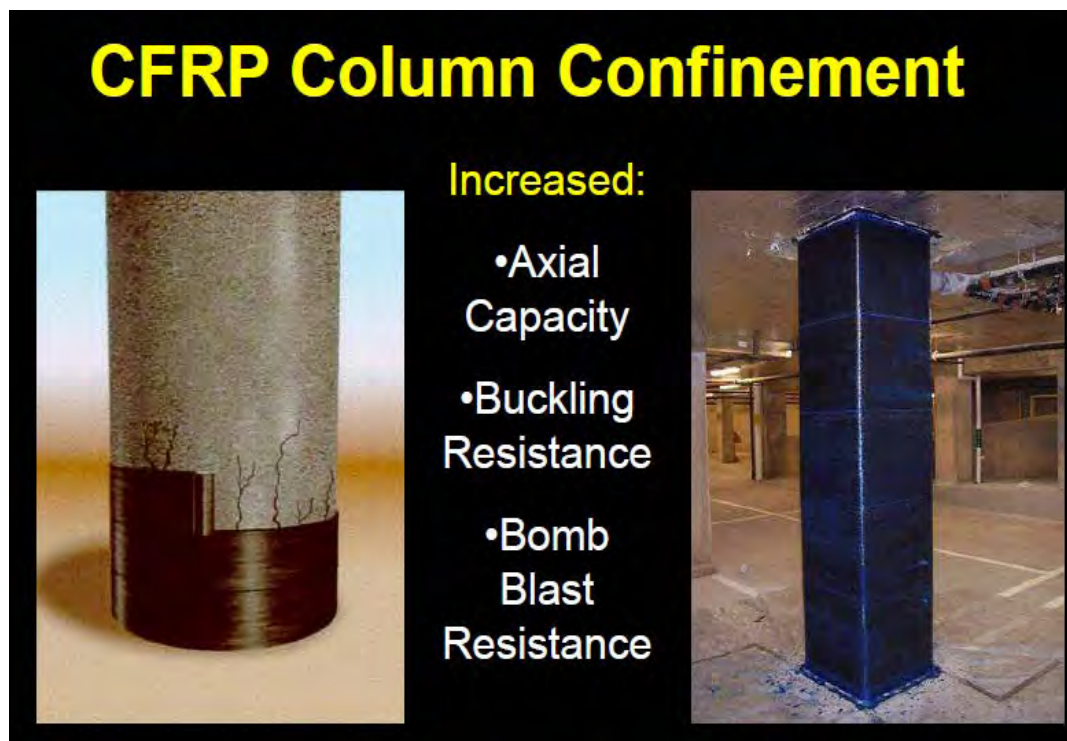
Figure 4.15 Effect of FRP for strengthening RC columns at resistance .

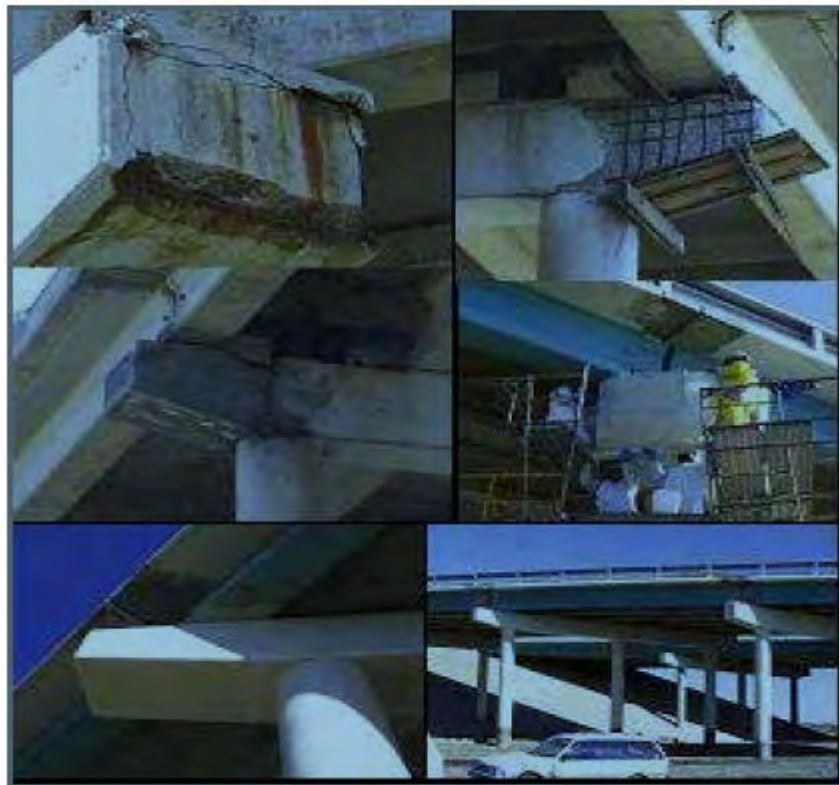
- Corrosion in reinforced concrete structures causes deterioration of infrastructure.
- Structures in or near marine environments are especially vulnerable.
- A widely promoted method for protecting structures in corrosive environments is the application of FRP composite wraps over the surface of the concrete elements.
- Corrosion due to chloride ingress is purportedly arrested by the prevention of further chloride contamination and penetration by the oxygen and water needed to continue a corrosion process that has begun or has caused damage.

Figure 4.16 .Corrosion protection by FRP

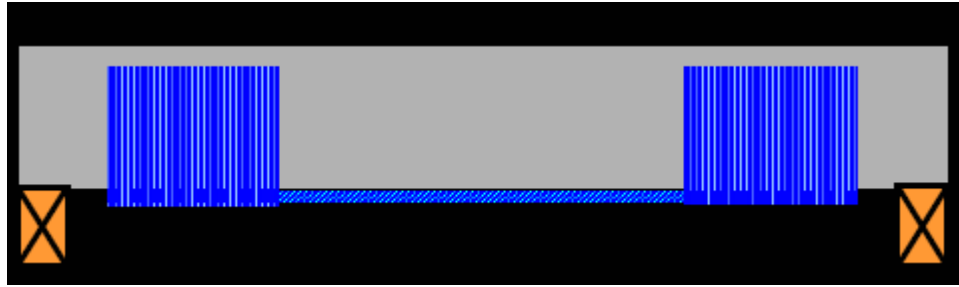
Figure 5.6. Beam U wrap.

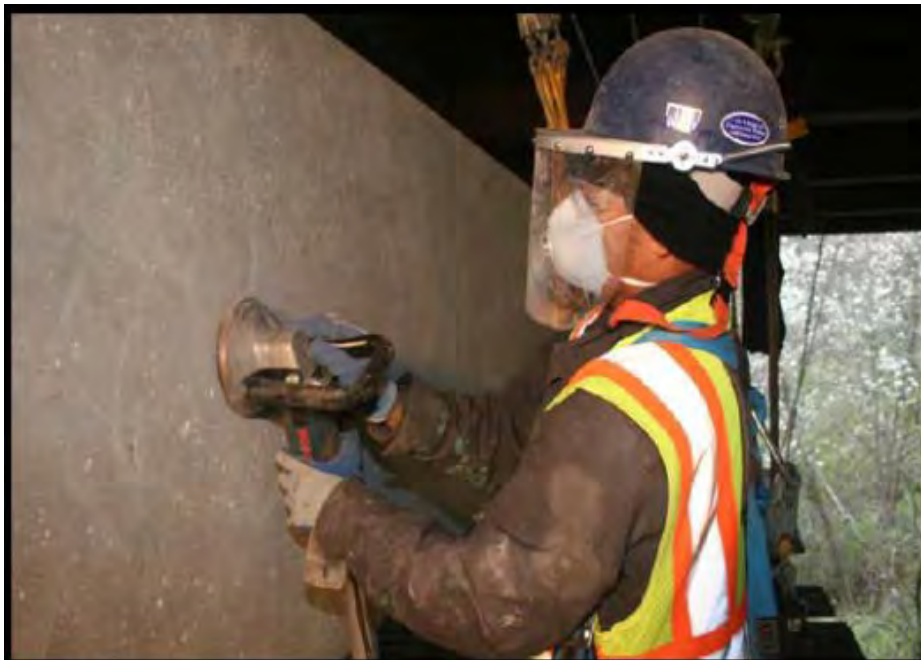
1. Surface preparation: This includes
 - a. Grinding to the surface to remove dust and cement loose layer.

Figure 5.7. Grinding to the surface.

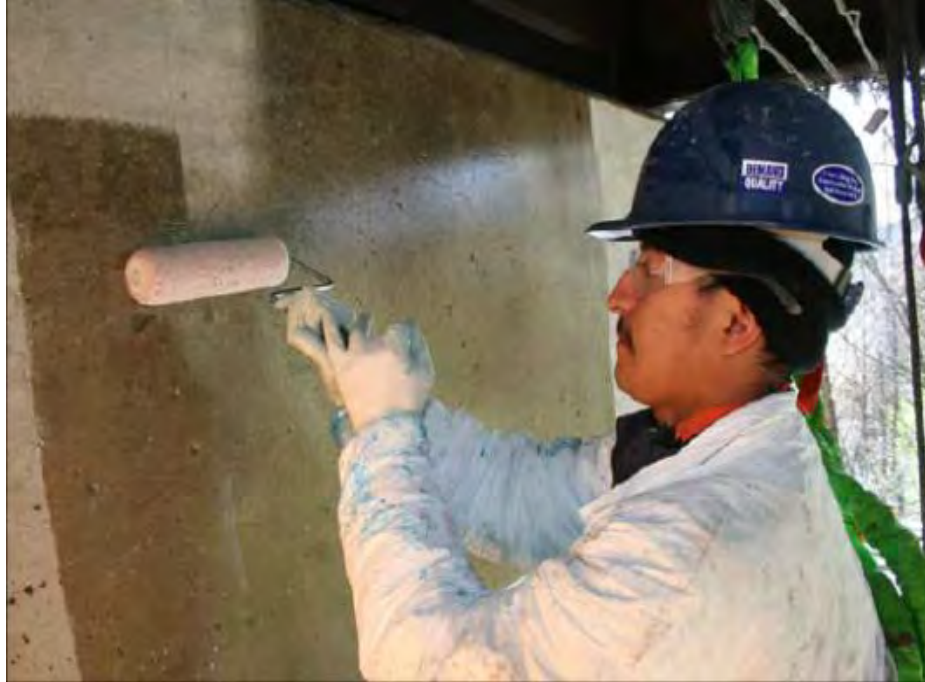
- b. Repair of hairline cracks, if any.
 - c. Application of Primer

Figure 5.8 Application of primer .

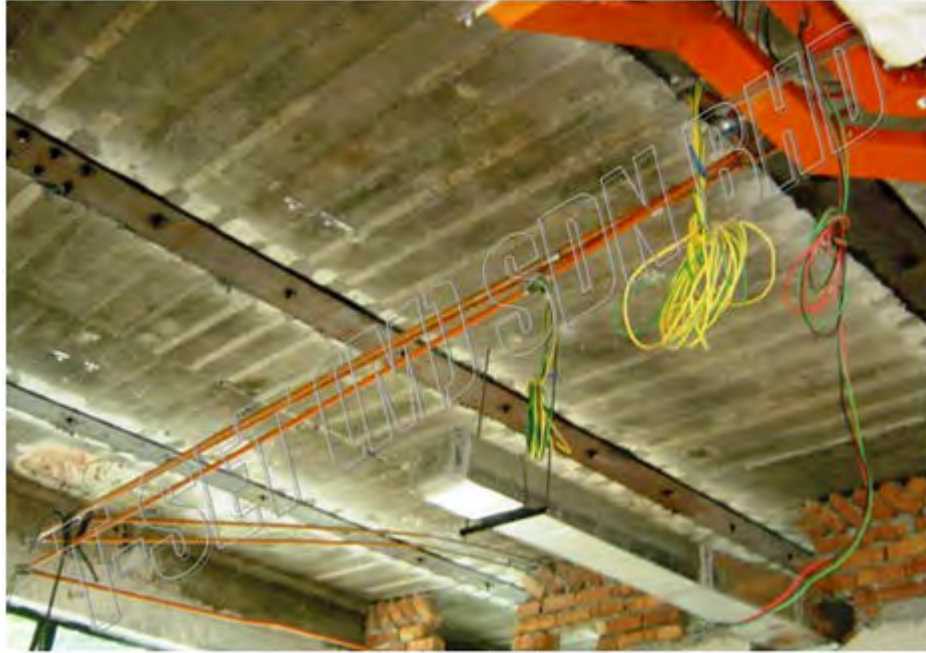
Design procedure is based on general principle concerning the concrete design of glued joints or glue–bolt and glue–dowel joints. The basic assumption is that the integrity of the plate–adhesive and adhesive–concrete interface is maintained and that structural integrity prevails up to the expected peak load .

Figure 6.3 Strengthening a RC slab by external steel plate bonding.

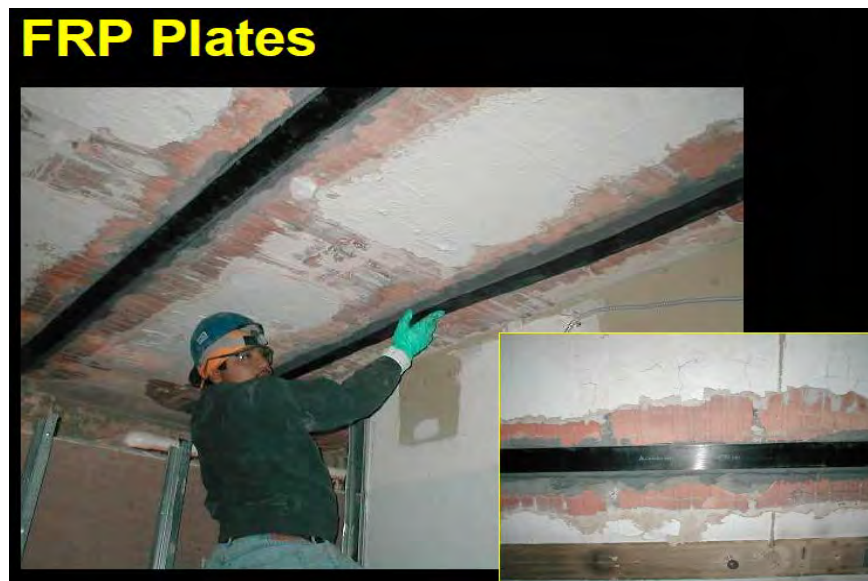
Generally speaking, the two-way RC slabs are elements subjected to flexure with irrelevant shear effect. That is why they are susceptible rather to flexural than shear failure. This particularity makes the use of composite materials in two-way RC slabs strengthening to be considered as an optimal solution. In addition to the important increase in serviceability and flexural capacity, using of FRP strengthening methods is justified by its unlaborious appliance. The reserve in using of FRP materials in strengthening of flexural structural members is the brittleness of such materials that can cause a decrease in the element's stiffness. The retrofitting method, same as one-way RC slabs, presumes the laying up of the lamellas or sheets bonded on the tensioned side by using resins, the FRPs being, off course, mounted parallel to both length and width of the slabs. This method increases the capacity in both directions of the element.

Figure 6.6 Strengthening of RC slab by using FRP.

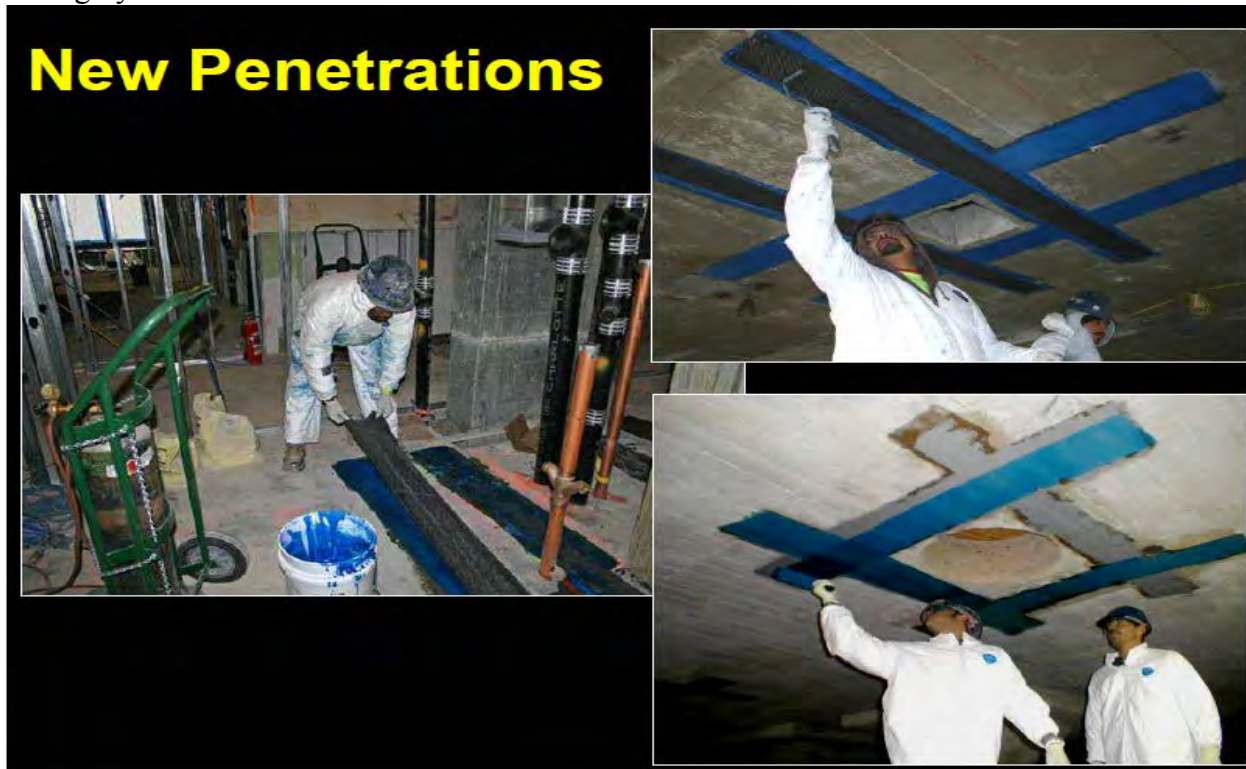
Another very simple technique is used , that installing a CFRP plates around the required opening before cut out the slab . this technique is the easiest and the fastest technique although it's highly relative cost .

Figure 6.14 Installing a CFRP plates around the openings.

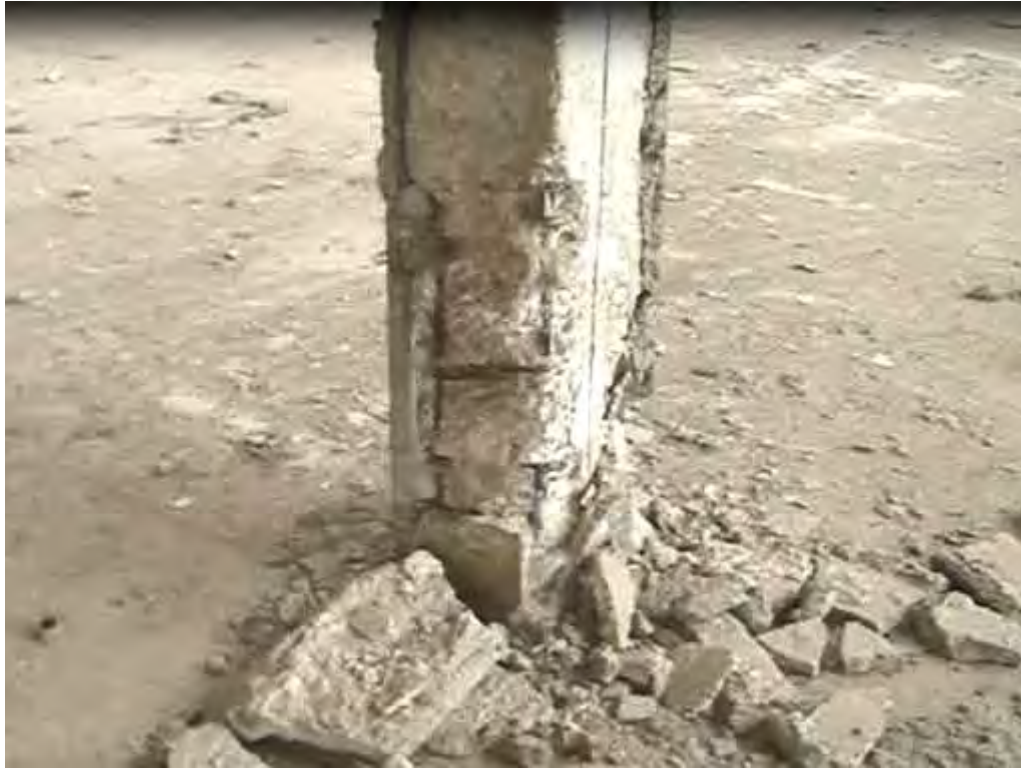
Figure A. 4 Columns concrete damaged.

By visual inspection it's clear that the columns hatched in figure A.3 are with dimensions of 35 X35 or less and a clear height of more than 6.30m and its concrete was damaged which mean it wouldn't be safe to use under these conditions as shown in figures (A.4, A.5 , A.6) .

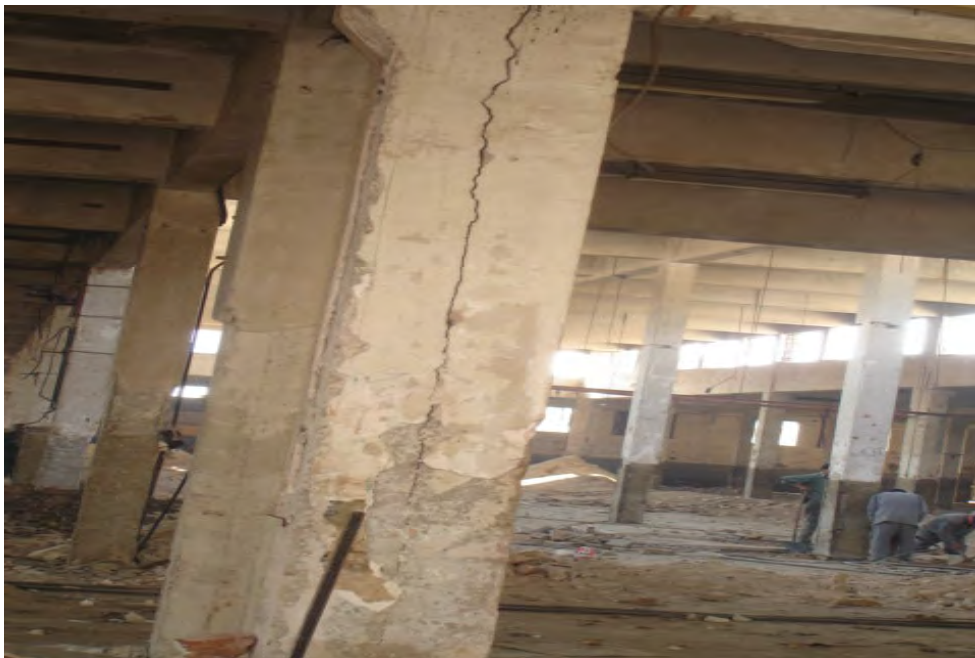
Figure A. 5 Column with longitudinal cracks.

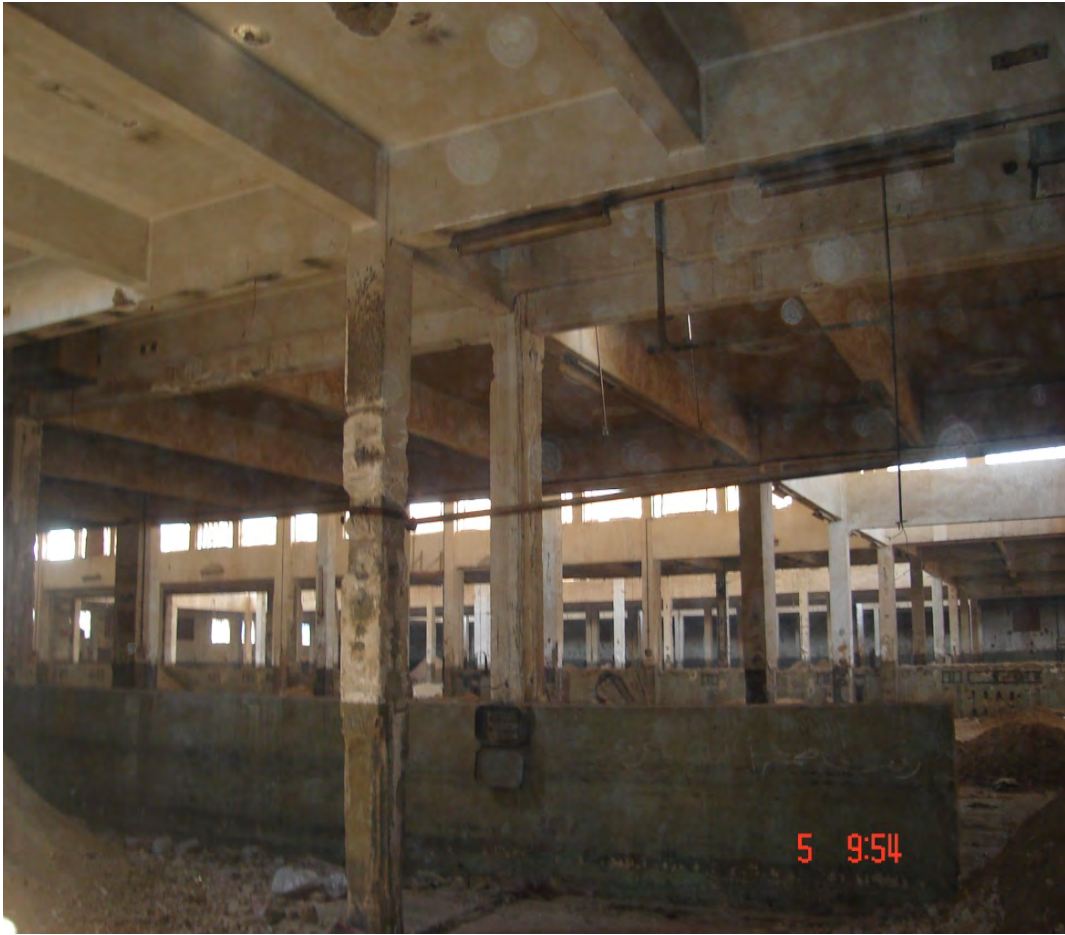
**Figure A.6 Columns with clear height of more than 6.3m
and a concrete dimensions of 35X35 or less.**

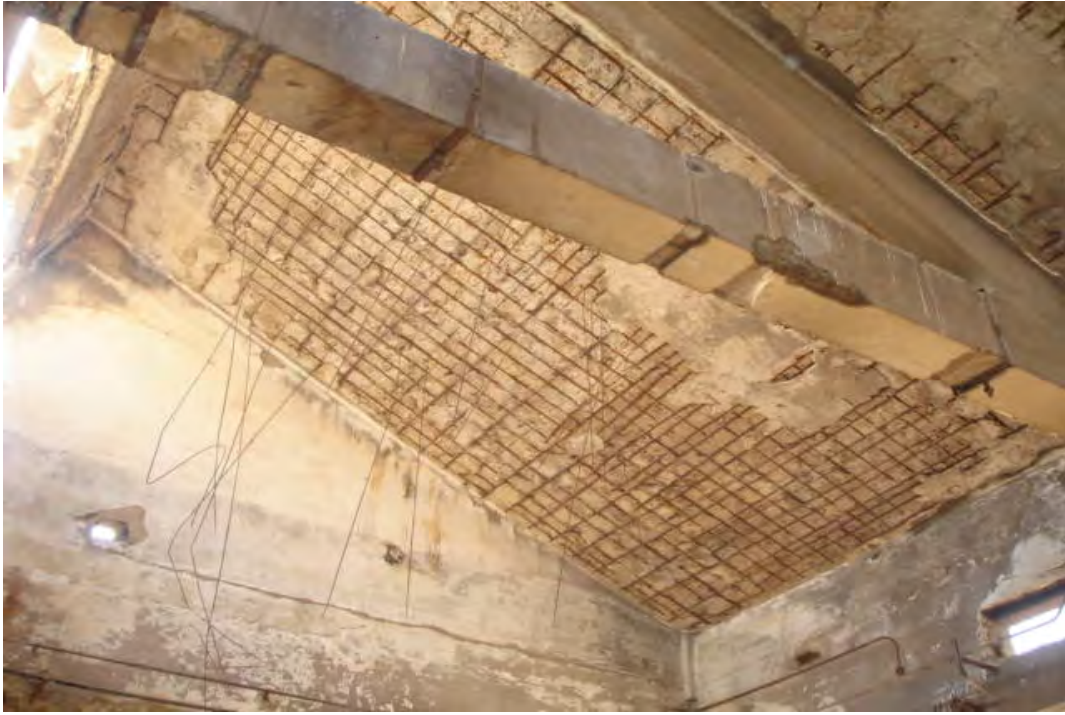
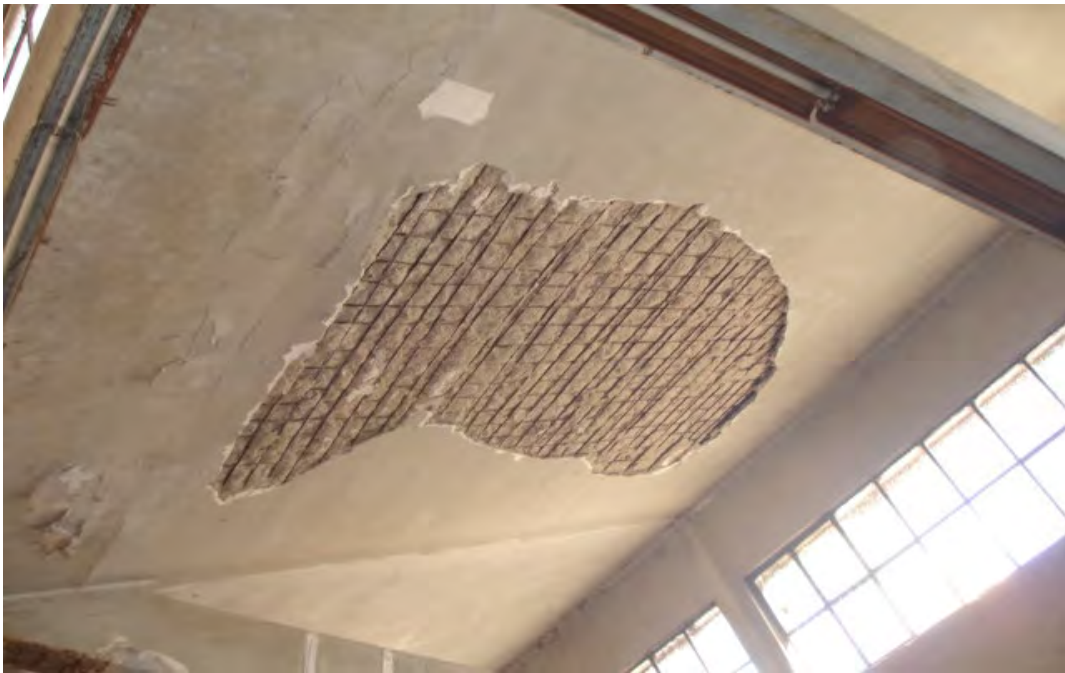
1- Some of the saw tooth lower girders were found wouldn't be safe to use under its condition of damaged concrete as shown in figures

Figure A.18 Damaged slabs in workshop (2).

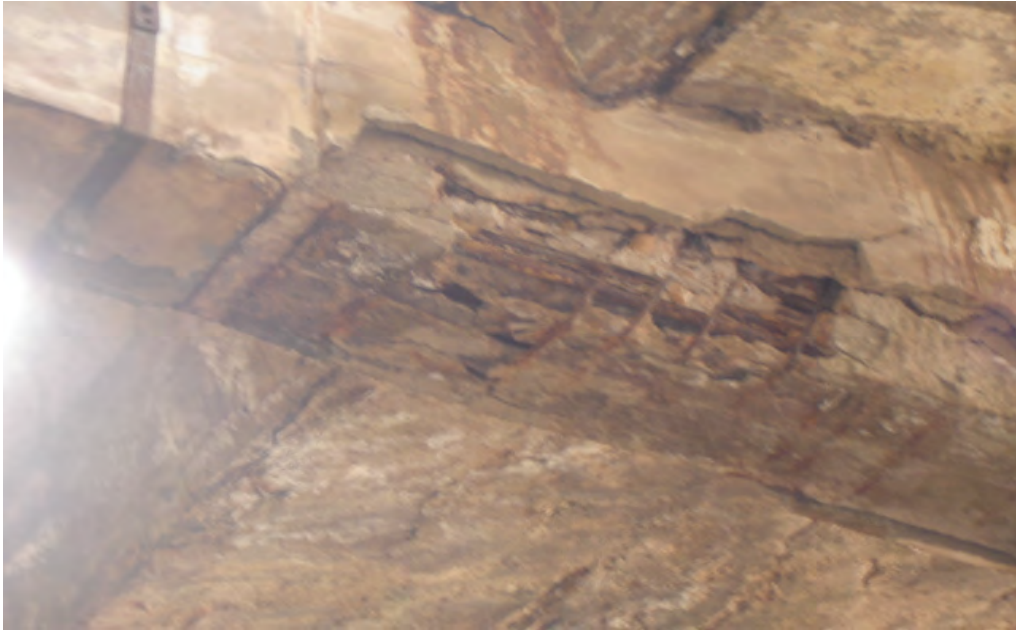
Figure A.19 Damaged girder.

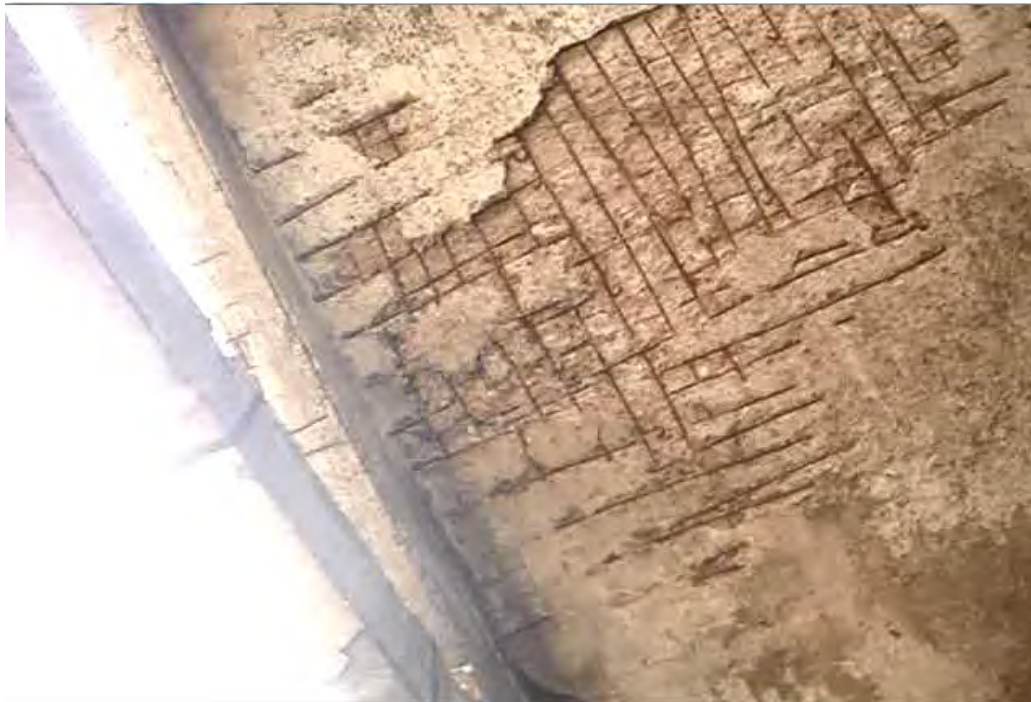
Figure A.20 Damaged slab and girder in workshop (2).

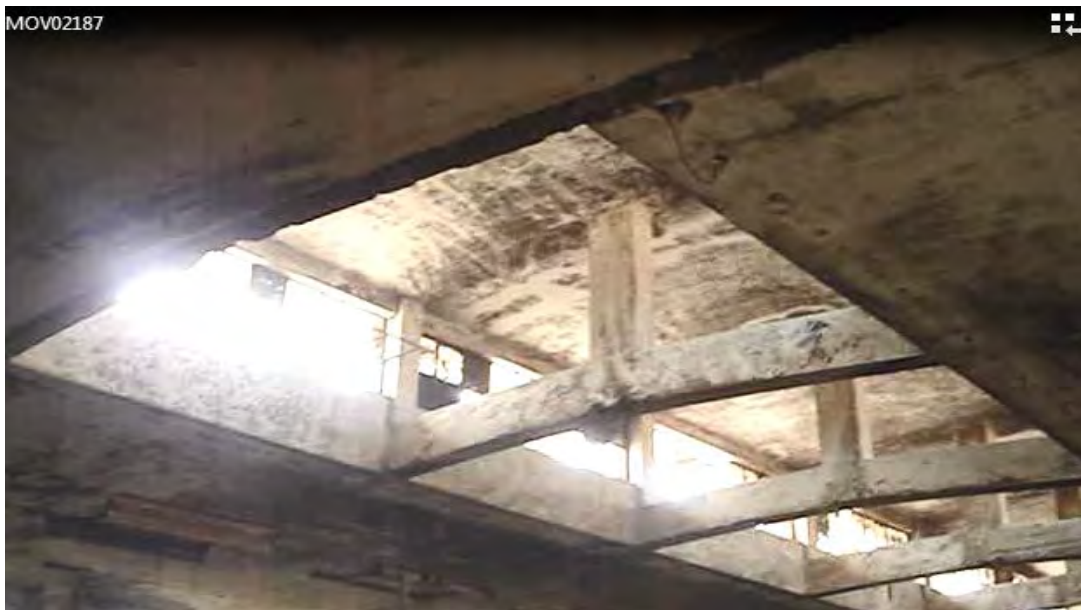
Workshop(4) has an arch girder system and by visual inspection it's clear that concrete members were in a good condition except some surface cracks , and by making of nondestructive tests and calculations it was found that concrete members acceptable to reuse without strengthening , just surface cracks should be treated .

Figure A.29 Workshop (4) members with good condition.

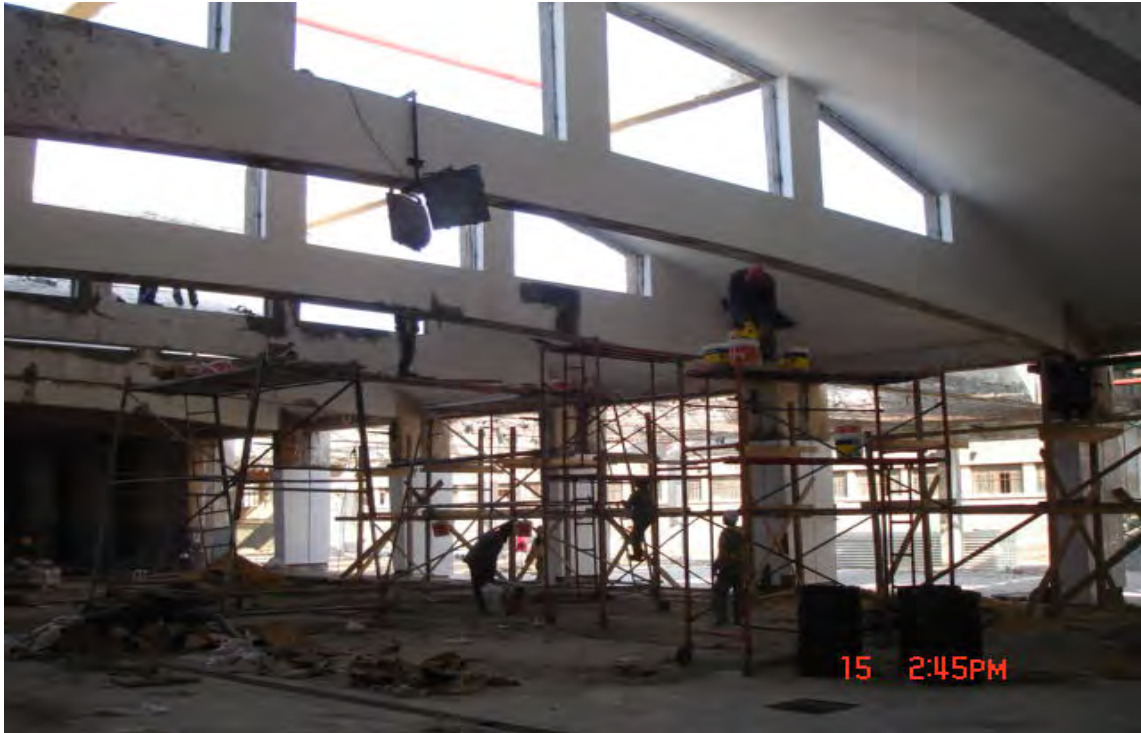
Surface cracks treated by mean of injection.

Figure A.30 Workshop (4) after repairing and coating.

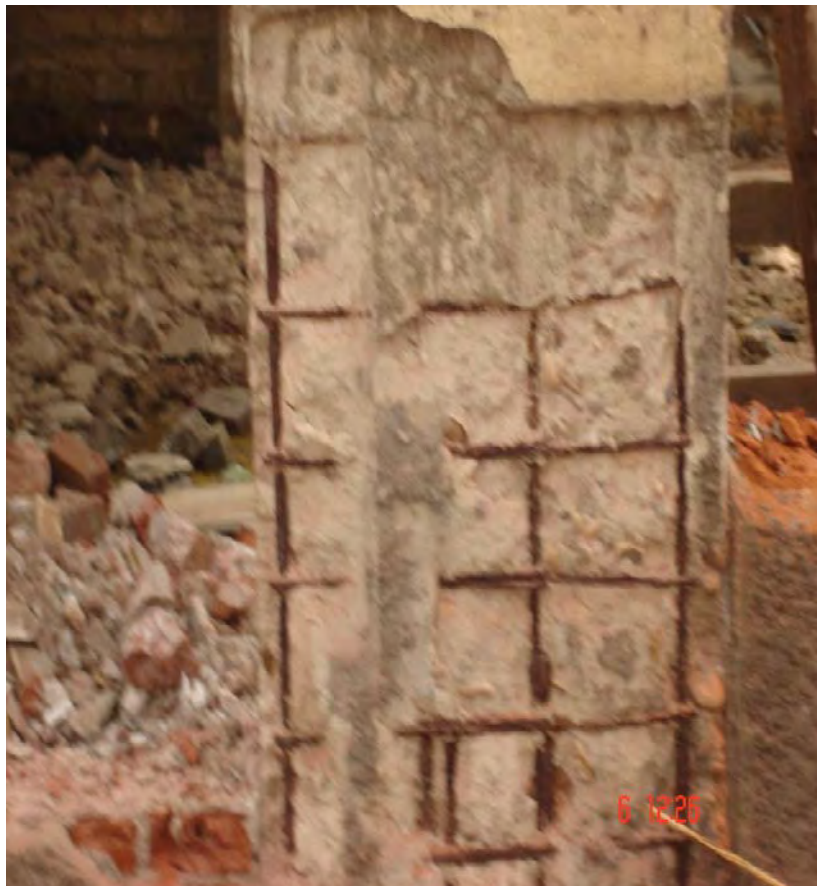
Figure A.33 Damaged column in the first level.

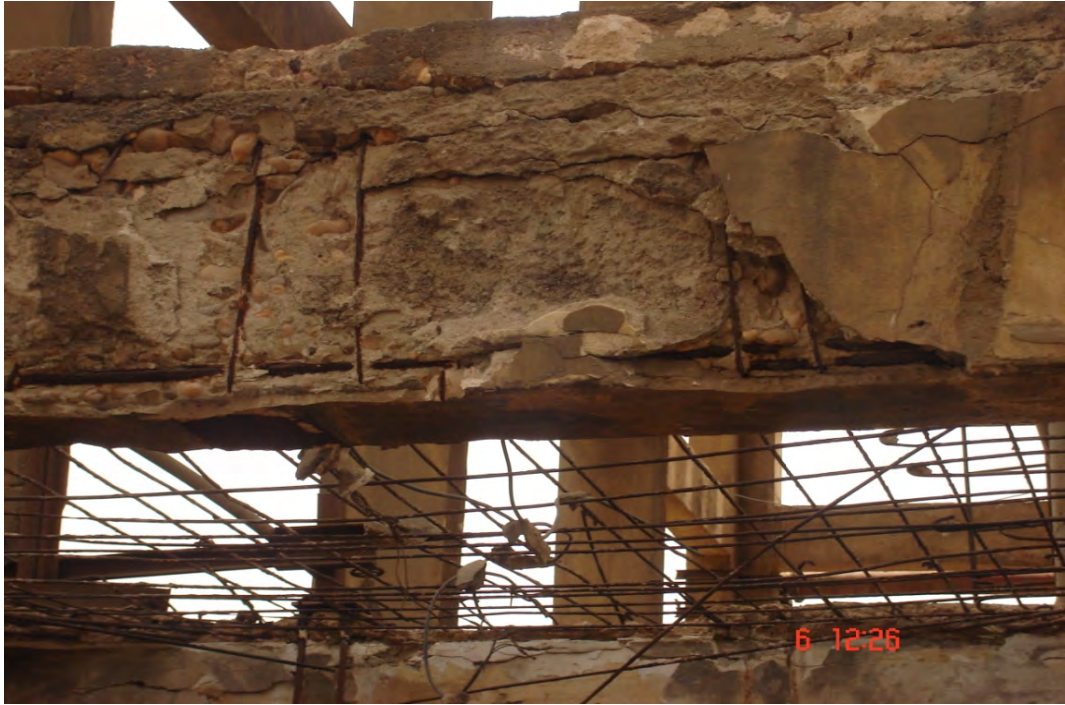
Figure A.34 Damaged Beam in the first level.

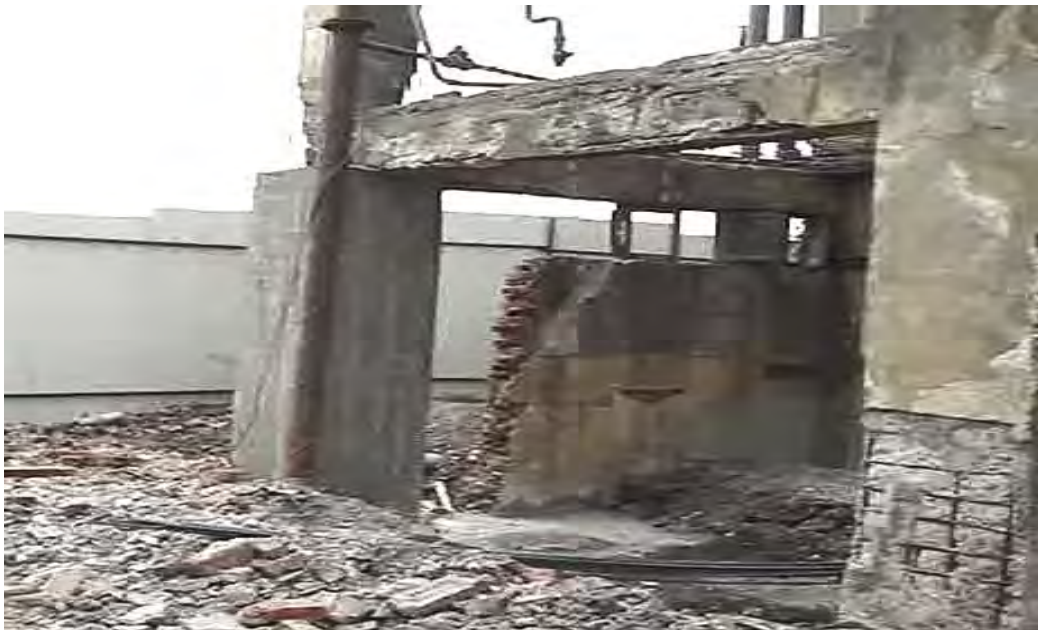
Figure A.35 Damaged Beam and column in the first level.

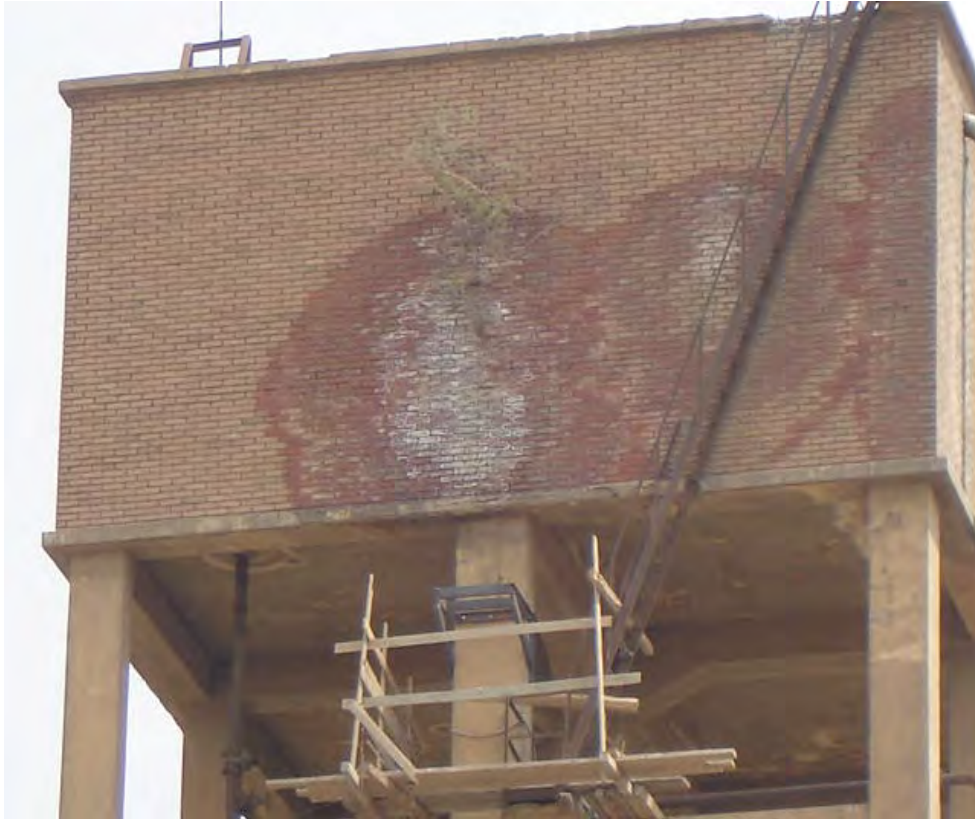
2- Tank body (RC walls, RC floor and RC slab) concrete was completely unsuitable to reuse and it wasn't any isolation due to water as shown in figure A.36.

Figure A.36 Tank body water effect due to not isolation.

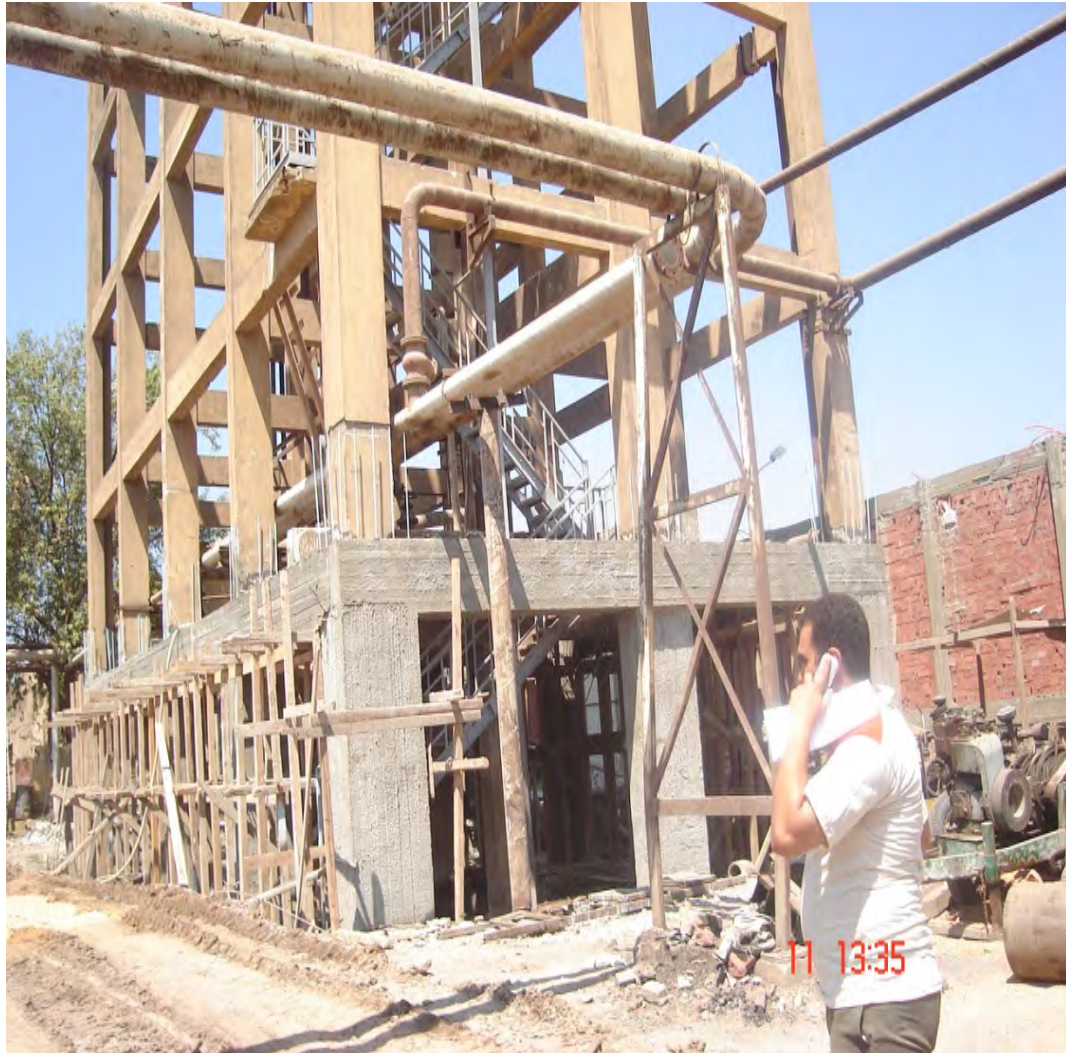
Figure A.40 Completing of columns and beams concrete jacketing.

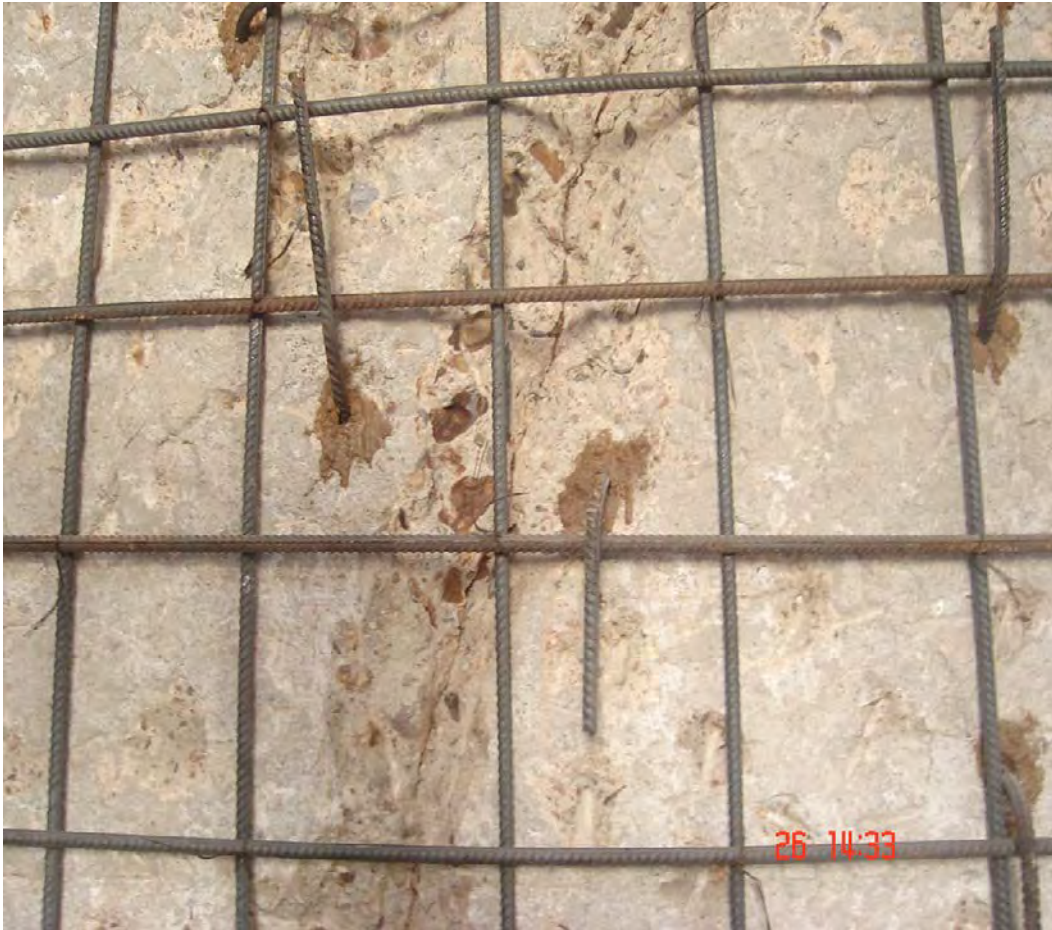
Figure A.43 Dowels between tank wall and the new layer.

2-Tank body decided to repaired by installing a new reinforcement mesh and cast a new concrete layer as shown in figures (from A.41 to A.43).
