طرق تدعيم العناصر الخرسانية المسلحة

بحث تطبيقي مقدم من

للحصول على ماجستير الهندسة في الهندسة
المدنية

ABSTRACT

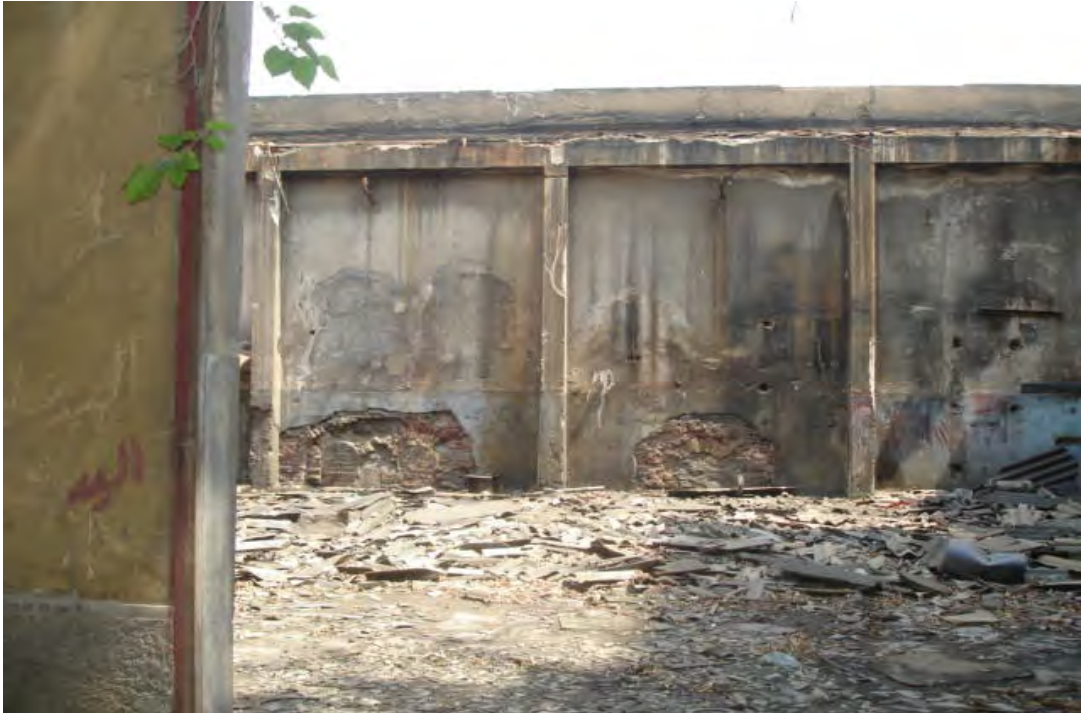
Figure A.45 Damaged fence.

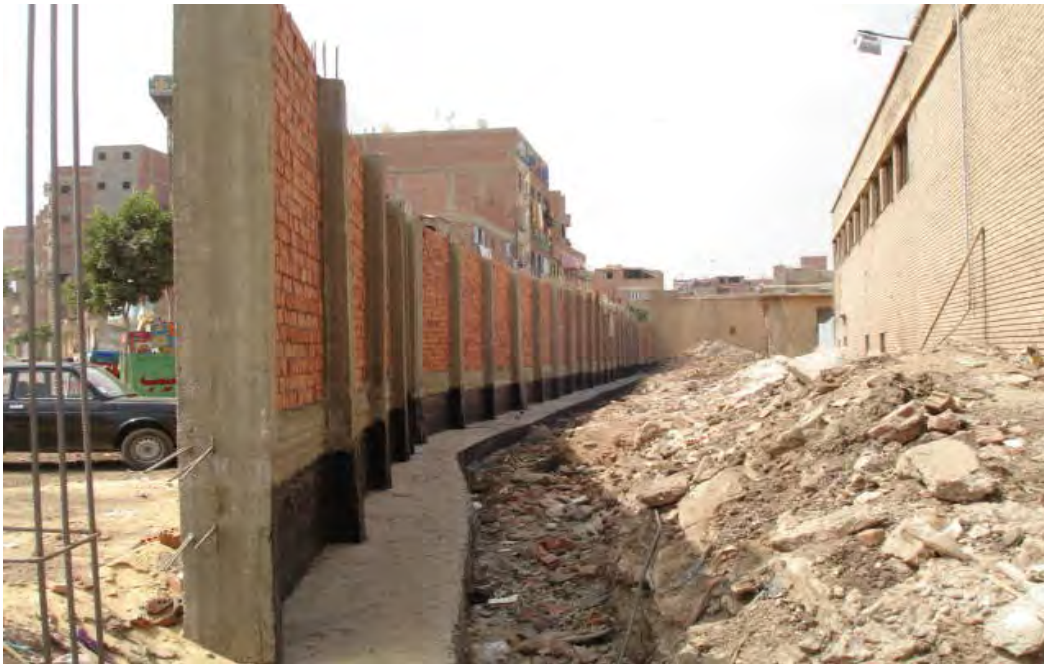
After a feasibility study it decided to choose the first alternative as it was more economic because of the long length of the two sides (104m, 86m) as shown in figure which means a large number of elements to be strengthened.

Figure A.46 New fence.

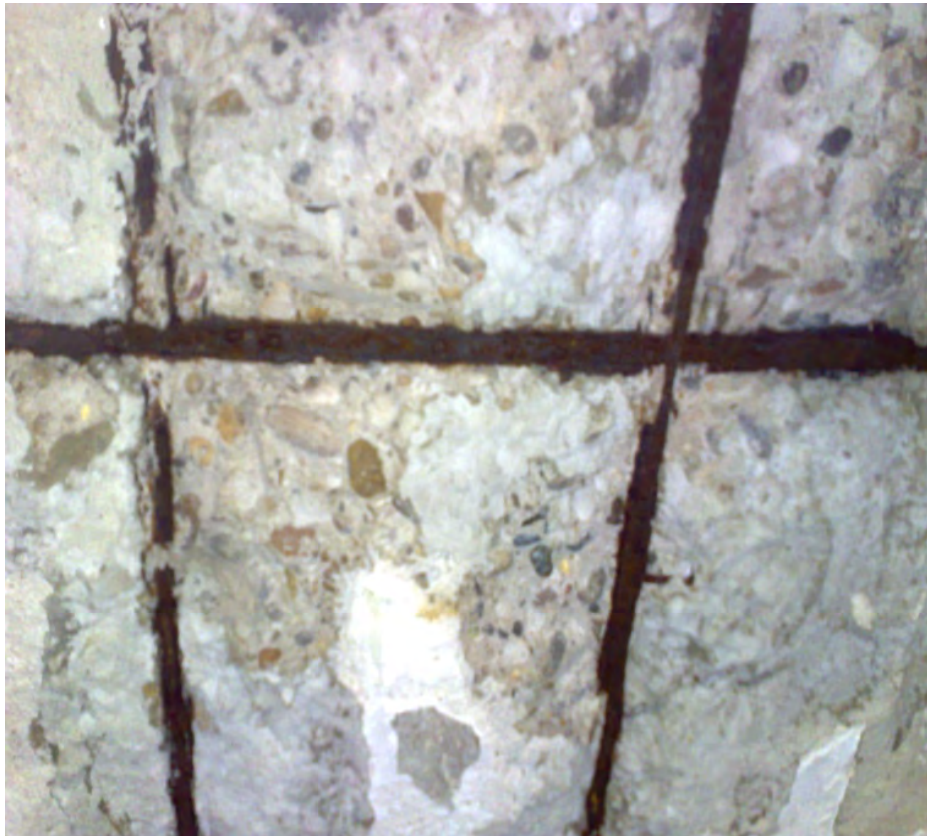
Figure C.2 Slab steel corrosion.

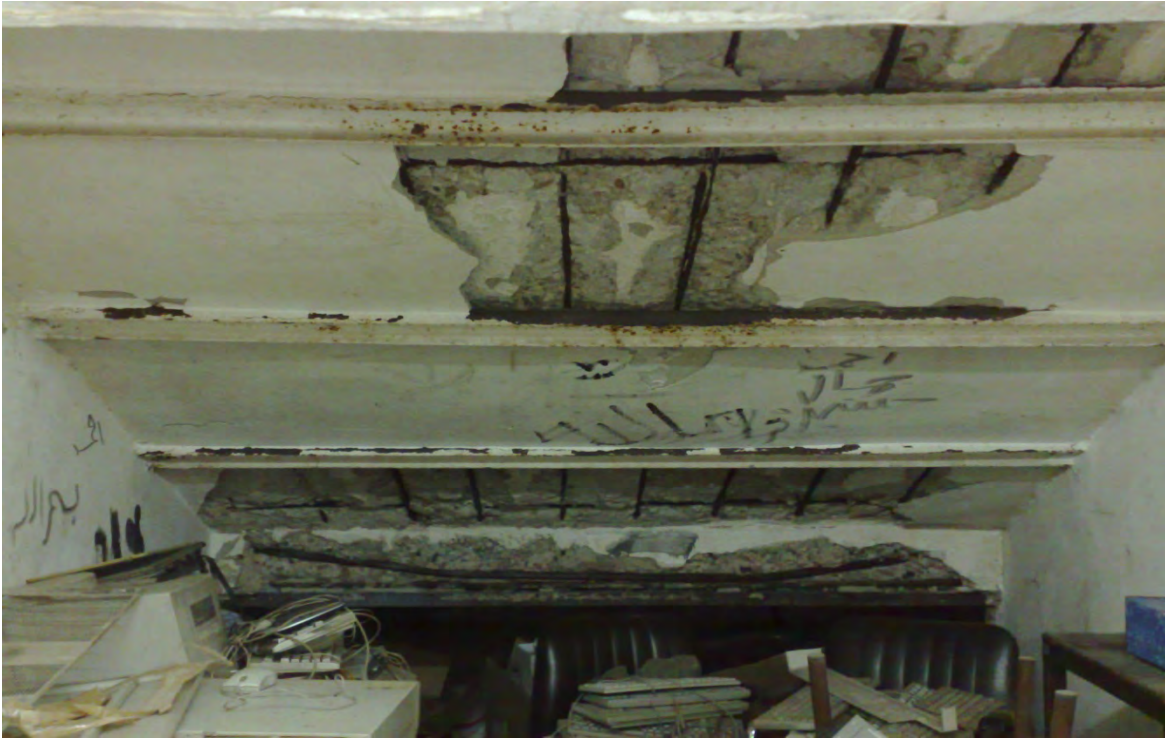
Figure C.3 Damaged stairs slab.

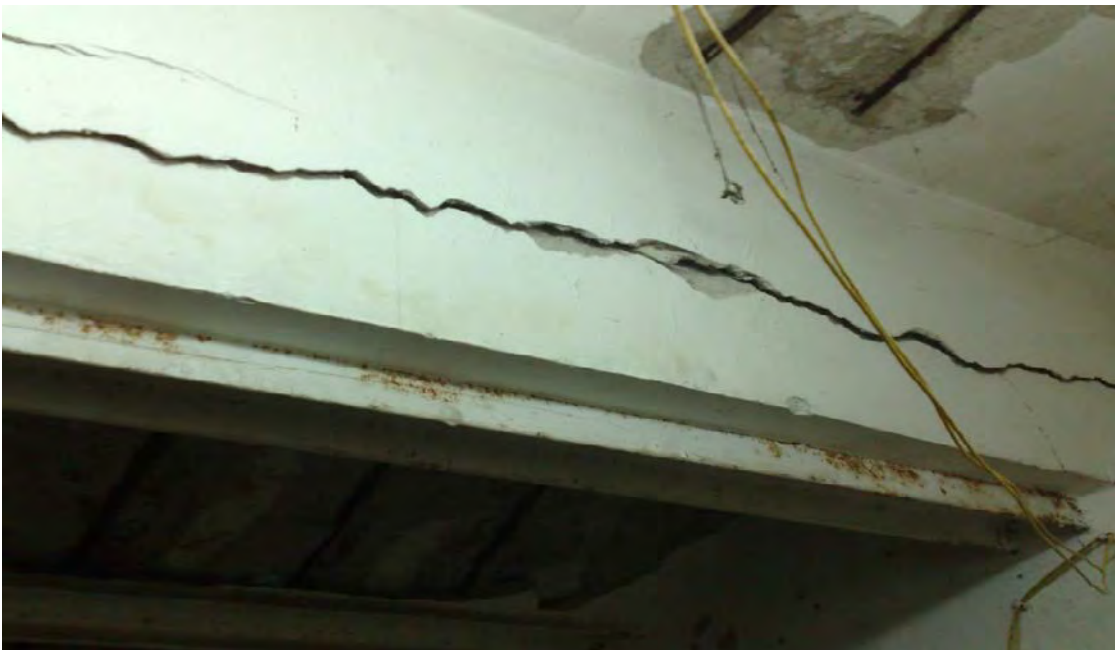
Figure C.4 Damaged beam.

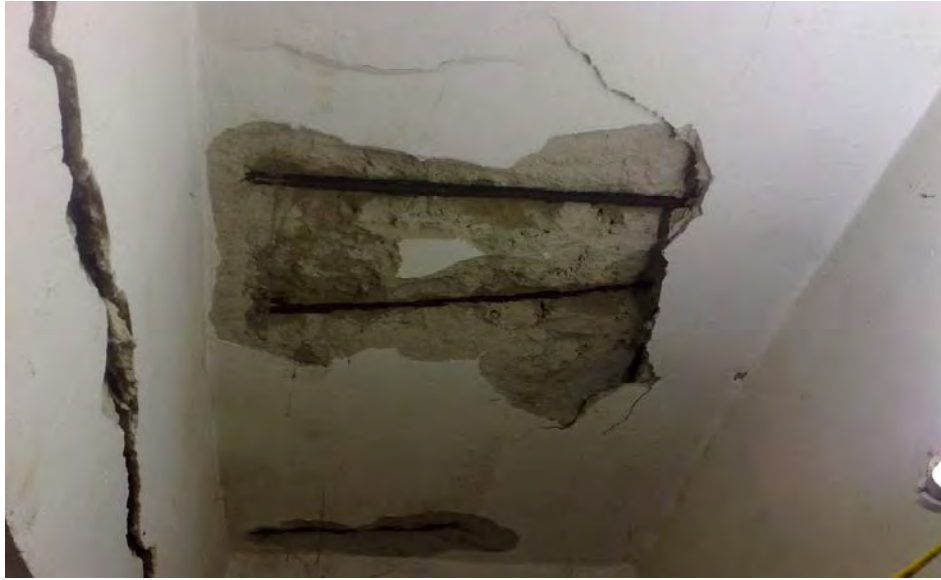
Figure C.5 Damaged beam and slab.

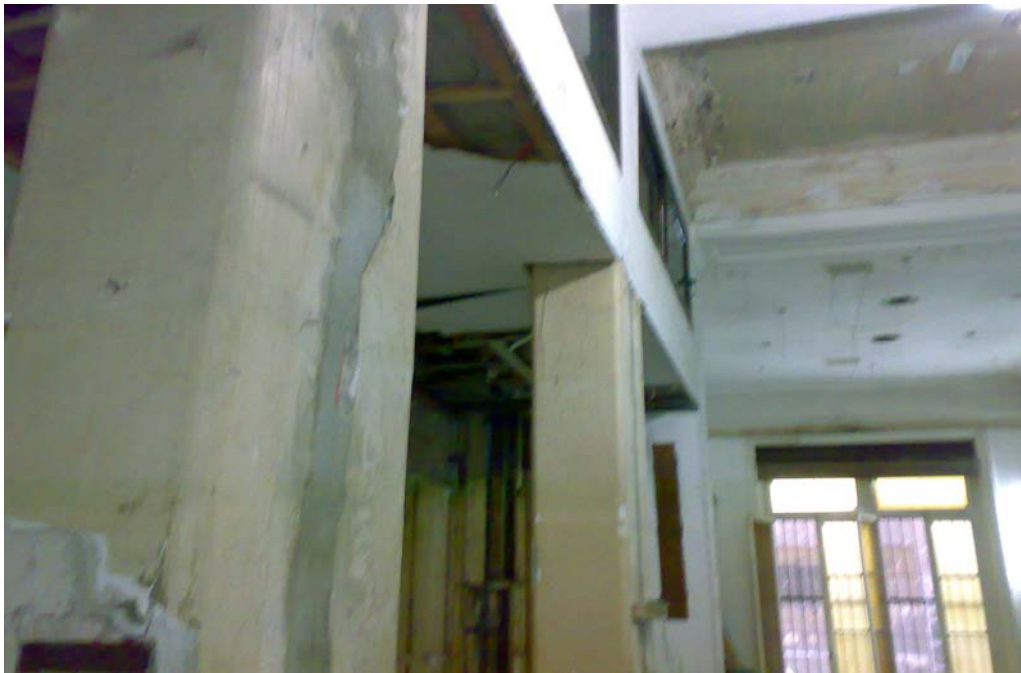
Figure C.6 Two RC columns need strengthening.

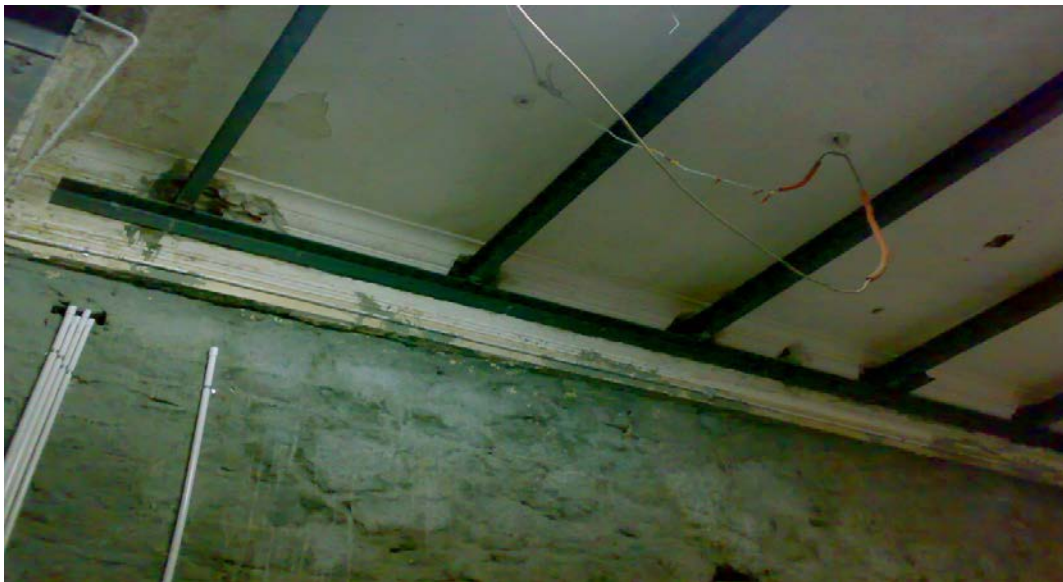
FigureC.9 Damaged slab strengthened by steel beams.

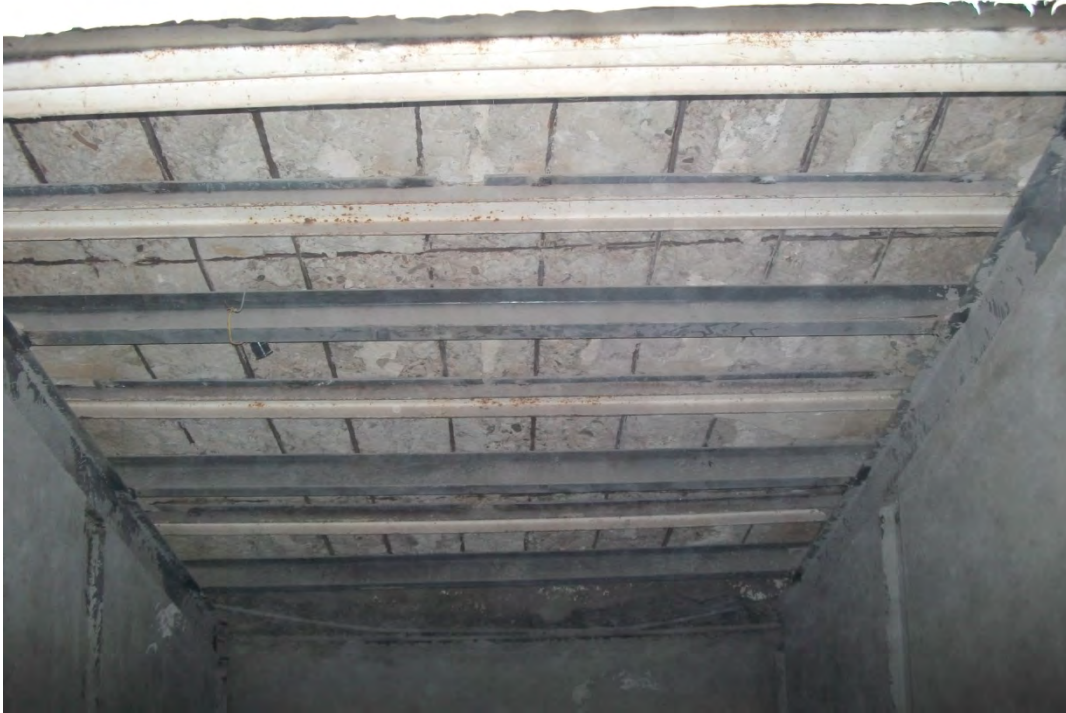
Figure C.10 Stair slab strengthened by steel beams.
