FRP REPAIR TECHNIQUES FOR R.C. BEAMS PRE-DAMAGED IN SHEAR

Nabil H. El-Ashkar, Alaa M. Morsy, and Karim M. Helmi
Construction and Building Engineering Department
Arab Academy for Science, Technology and Maritime Transport
Alexandria, Egypt

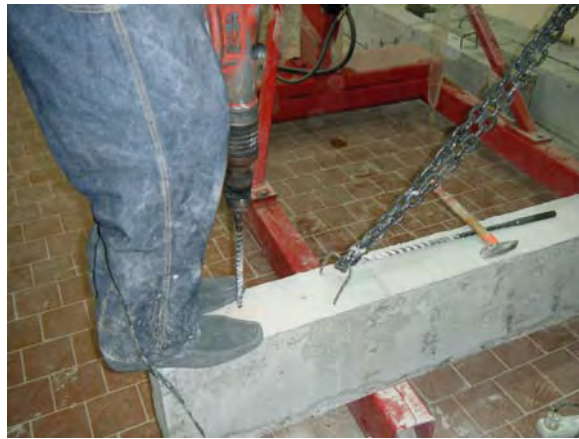
In this research two different techniques for repairing or strengthening RC beams against shear were used. The first technique used Internally Embedded Reinforcement (I.E.R.). In this technique 12 mm CFRP bars were embedded in circular holes drilled through the depth of the beams. All the bars had a spacing of 150 mm. Figures 2, 3 show the preparation work for the repaired specimens using I.E.R. technique.

Figure 2 Drilling of holes for specimen IER

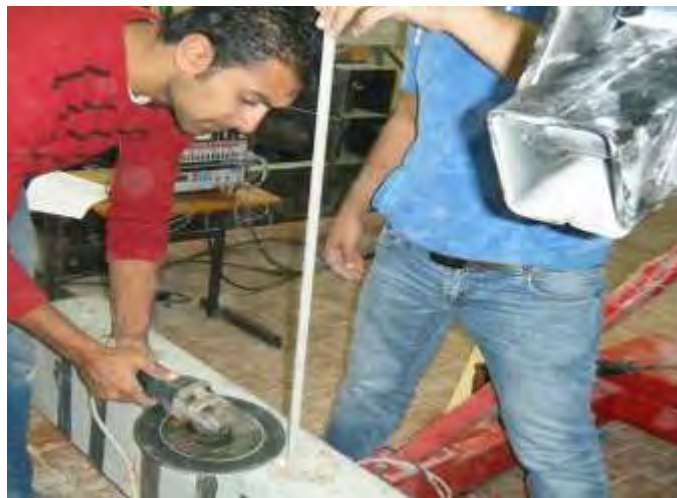
Figure 3 Installing of reinforcement in specimen IER

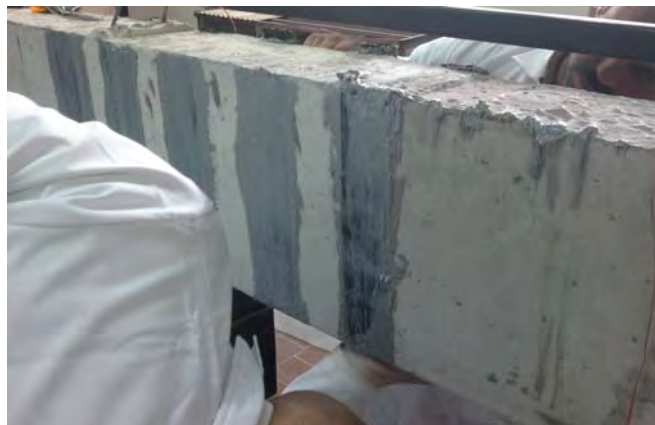
In the second technique CFRP sheets were externally used to repair or strengthen the beams in shear. The CFRP sheets were externally bonded (E.B.) to the sides and bottom of the beam forming a U shaped wrap around three sides of the beam. A single layer of 60 mm wide sheets with a spacing of 150 mm was used to strengthen these specimens. Figure 4 shows the strengthening of EB specimen. The configuration of the specimens was chosen so all specimens would have an equal amount of material.

Figure 4. Strengthening of specimen EB

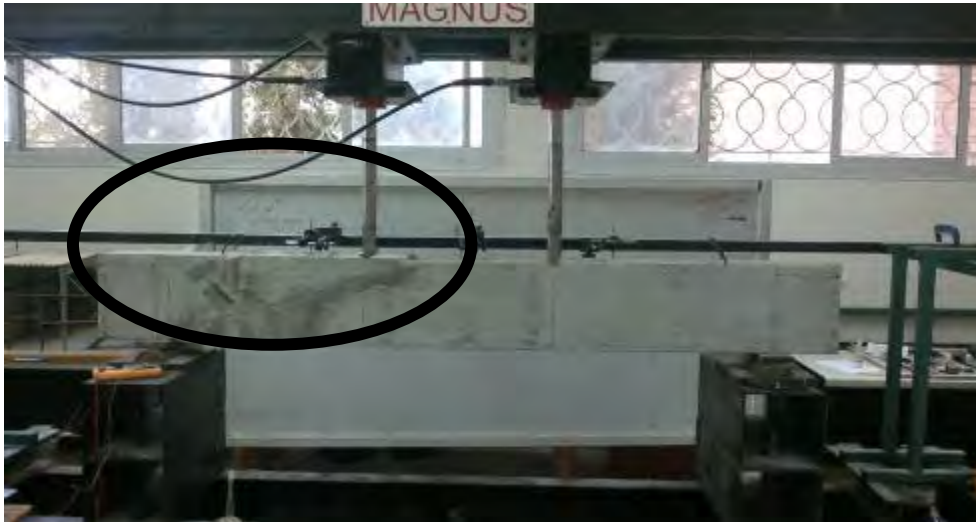
CFRP sheets to the target surfaces of the tested beams. 12 mm V-Rod CFRP bars manufactured by Pultral Inc. were used for IER specimen, Sikadur 31 CF epoxy adhesive was used for fixing the internally rods inside the holes. The cracks in the control beam was patched after testing to failure using cementitious materials as shown in Figure 5 Repaired Specimen. Afterwards the beam was repaired using the I.E.R technique, and then retested.

Figure 5 Repaired Specimen

After the failure of the control specimen, the loading was continued beyond the failure (maximum) load decreasing till about 70 % of the maximum load which caused a lot of damage to the beam itself and more than one major visible crack could be noticed very easily by visual inspection. After unloading, and since the beam suffered from intensive damage, repair works to this beam was conducted included using cementitious material as shown in Figure 5 Repaired Specimen. Afterwards the failed control beam was repaired using the I.E.R method. The control beam was reinforced with four CFRP rods 150 mm apart located starting at 35 cm from the edge of the weak side in the beam. After retrofitting, beams were reloaded to failure. The specimen showed a more brittle failure than the control specimen but it only reached an 80 % level of the control beam maximum load. This may be due to the extensive damage took place during the first loading.

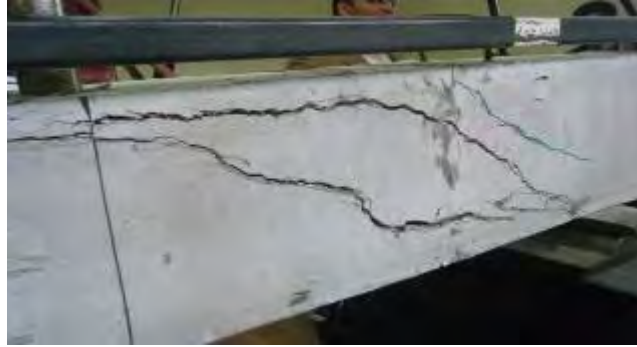
For the control specimen the first visible crack appeared at a load of about 70 kN. The crack extended from the point of loading to the support in the weak side. As loading progressed, the crack widened, and another major crack appeared in addition to several minor ones as seen in Figure 7. The specimen failed at a load of 100 kN (for one jack only). Although the failure was brittle it was less sudden than in the case of all other specimens.

Figure 7 Crack patterns of control specimen

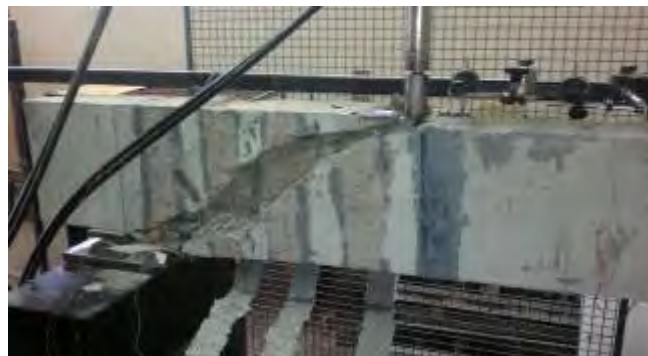
Post failure examination of the specimen showed a similar crack pattern to the control specimen as seen in Figure 8. It was noticed that the bonding failure took place in the concrete thin layer adjacent to the sheet, not in the adhesive epoxy.

Figure 8 Crack patterns of specimen S-EBR

The first visible crack appeared at a load of 78 kN between the sheets. As loading progressed, cracks widened then the specimen finally failed in a brittle manner at a load of 130 kN after debonding started at the second sheet after the support. Then with further loading the failure occurred progressively one sheet at a time.

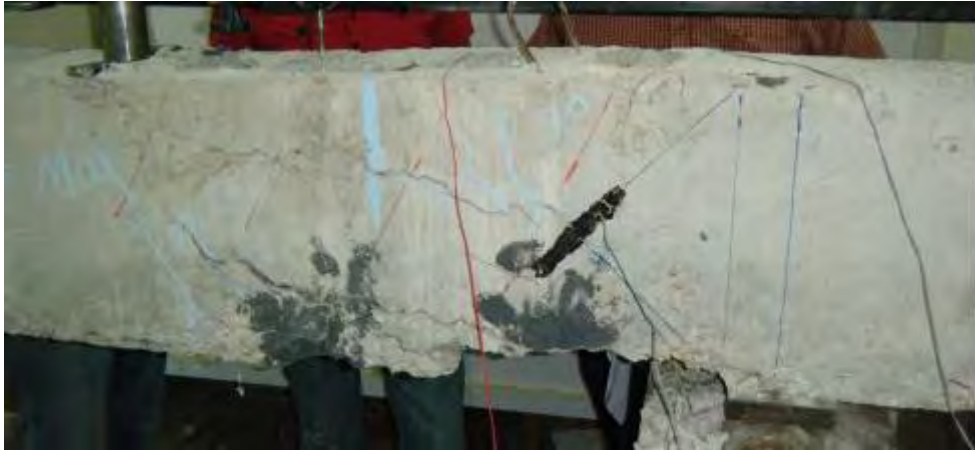
For the internally embedded reinforcement specimen, the first visible crack appeared at a load of 70 kN at the loading point at a steeper angle than the case of the control specimen and even when compared with the specimen strengthened with externally bonded sheets. This can be related to the crack arresting action of the embedded bars which altered the cracking pattern compared to the control specimen. Several other cracks appeared and widened as the loading progressed, although at steeper angle as seen in Figure 9. Failure occurred suddenly at a load of 138 kN due to the de-bonding at the thin layer of concrete adhered to the CFRP bars. Some de-bonding occurred between the inner core of the CFRP bars and the outer

Figure 9 Crack patterns of specimen S-IER

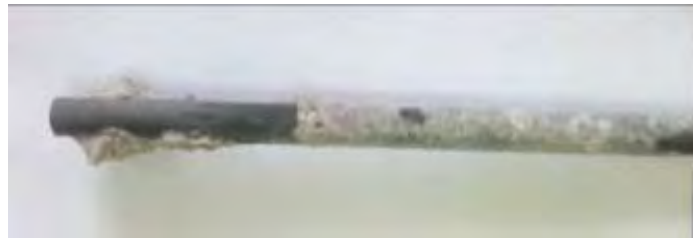
coating of the bar as shown in figure 10. This can represent a weak point for the FRP bars as this outer coating is added to the bar to enhance its bonding properties with the surrounding concrete specimen.

Figure 10 Debonded CFRP bar
