Experimental Investigation on Vulnerability of Precast RC Beam-column Joints to Progressive Collapse

Abstract

Keywords: *progressive collapse, precast, beam-column connection, blast loads, testing*

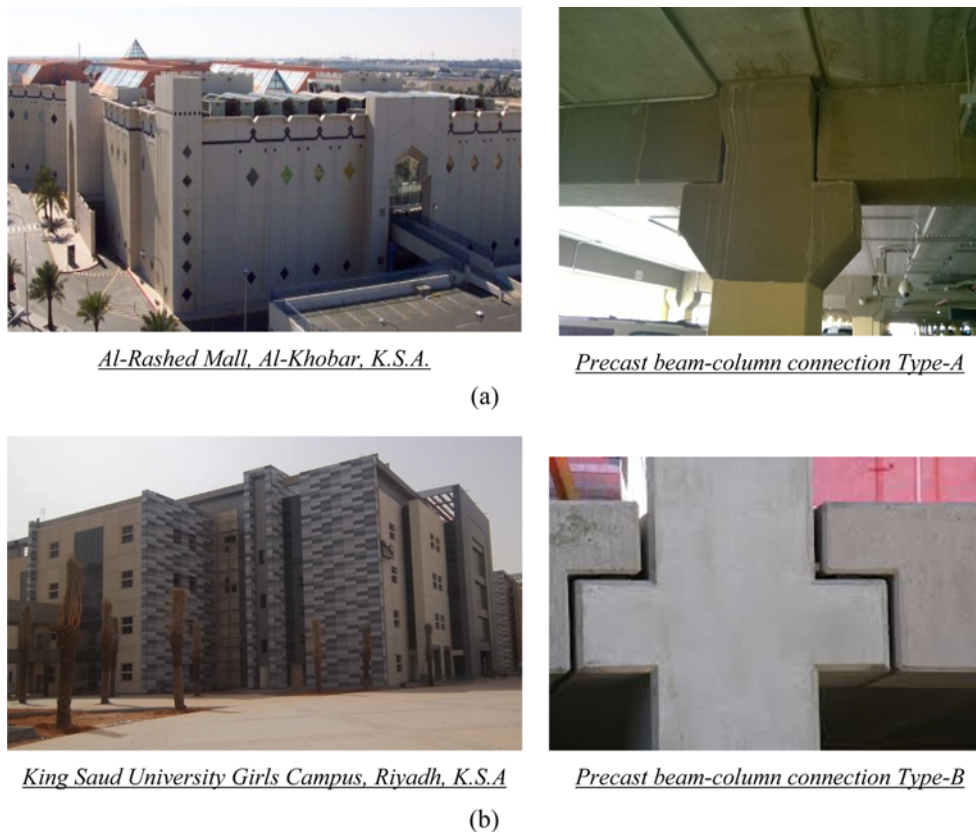
Fig. 1. Examples of Typical Beam-column Connections in Precast Buildings in Saudi Arabia: (a) Precast Type-A Beam-column Connection, (b) Precast Type-B Beam-column Connection

The precast Reinforced Concrete (RC) structures are preferred mainly because of the ease of their constructability. In the last few decades, precast RC structures have gained popularity in Saudi Arabia. The structural elements are produced in factories in a controlled environment and transported to the site where the individual elements are assembled and connected. Examples of typical precast buildings within Saudi Arabia are given in Fig. 1.

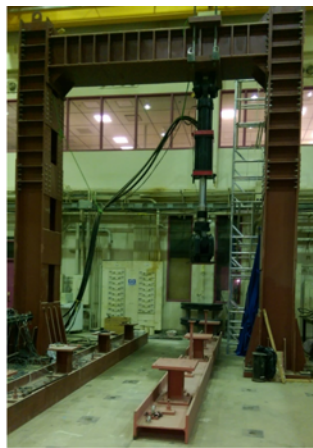
Fig. 8. Test Setup and Instrumentation Layout: (a) Loading Frame with Actuator and Rails for Supporting Specimen, (b) Instrumented Specimen PC-A (Taken from Elsanadedy *et al.* (2017)).

A steel loading frame shown in Fig. 8(a), which exists in the structural lab of King Saud University was used for testing the specimens. The susceptibility of a building to blast loading may cause a sudden column removal, which may end up with partial

A high speed data acquisition system was utilized to collect data at speed of 1 k/s. The individual beam and column members of the specimens were instrumented for measuring strains in the longitudinal and transverse rebars using strain gages. The center column and beam mid-span displacements were measured using extremely precise laser transducers. The instrumentation program also included measurement of end rotations of the beams using dual-axis inclinometers. The three-dimensional vibration of the specimen was recorded using a tri-axial accelerometer. Fig. 8(b) depicts the complete instrumentation layout for the precast specimen PC-A.

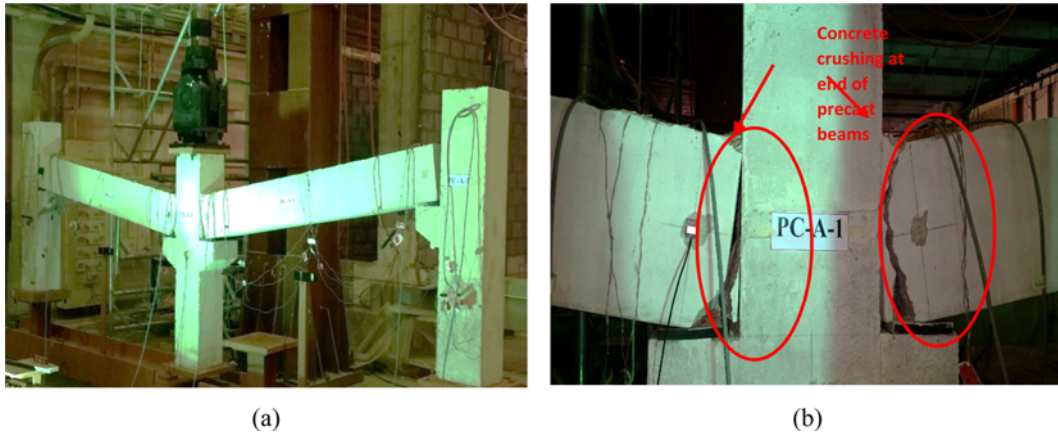
Fig. 10. Final Deformed Shape for PC-A Specimen at a Middle Column Displacement of 350 mm: (a) Final Deformed Shape, (b) Failure of Middle Joint

As seen in Fig. 10(a) for specimen PC-A, a proper hinge behavior was observed in the specimen which was expected. During the test, both the beams of specimen PC-A were found to rotate at their ends until the interior ends came in contact with the middle column, and the ultimate mode of failure was due to concrete crushing at the location of interior beam-column joint as seen in Fig. 10(b). Other than this, no other damage was observed in any members of specimen PC-A including beams and columns. It should be also noted that at the exterior connection end, the neoprene pad underneath the beam helped to absorb the energy thereby protecting the exterior corbel from damaging.

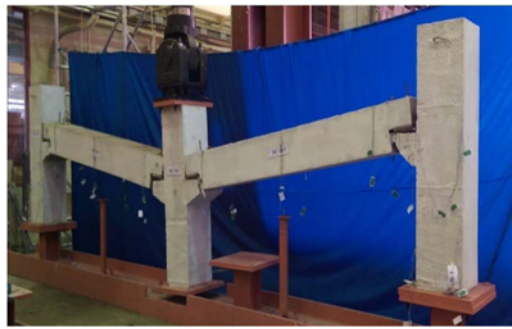
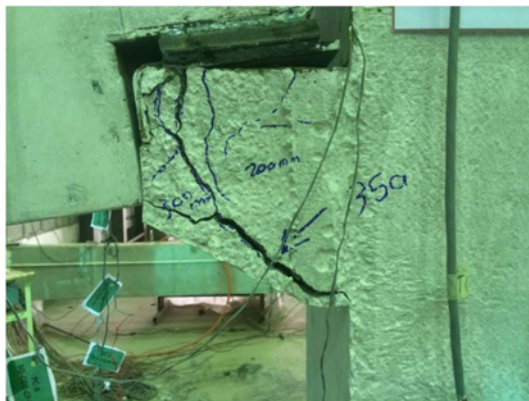
Fig. 11. Final Deformed Shape for PC-B Specimen at a Middle Column Displacement of 400 mm: (a) Final Deformed Shape, (b) Failure of Middle Joint, (c) Failure at End Joint

Figure 11 presents the final failure mode for the PC-B frame at the interior beam-column connection. As seen from the figure, a proper hinge behavior was noticed and the left and right beams

were found to rotate at their ends until failure occurred due to debonding of steel angles of the corbels near the interior column. Some minor cracks were also formed in the corbels of the middle column. As a result of beam rotation, stress concentration was observed in the column corbels at locations where the beam was bearing on the corbel. This resulted in bearing stresses thereby causing diagonal splitting cracks in column corbels as shown in Fig. 11(c). Debonding of some part of the steel angle from corbel concrete was also noticed. There was no noticeable damage to both the beams as well as the exterior columns.

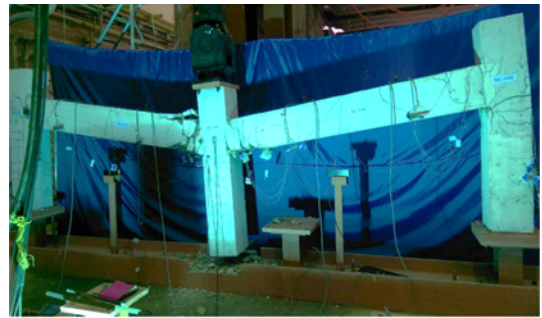
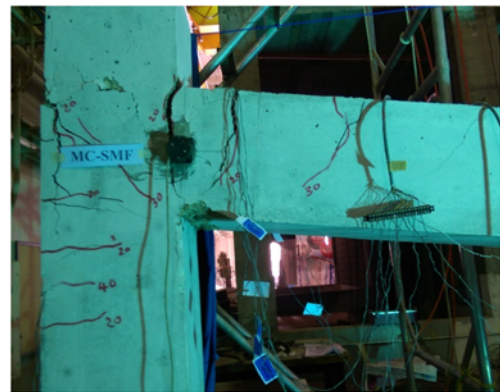
Fig. 12. Final Deformed Shape for MC-SMF Specimen at a Middle Column Displacement of 400 mm: (a) Final Deformed Shape, (b) Failure of Middle Joint, (c) Failure at End Joint

Figure 12 depicts the final failure mode for the MC-SMF frame at the middle beam-column joint. Failure of specimen MC-SMF occurred around the middle column due to plastic hinge formation in the beam area near the connection zone. As seen in Fig. 12(b), a plastic hinge was formed near the middle joint due to large plastic strains in the bottom steel rebars of the beam beyond their yield state (indicated by wide flexural cracks) accompanied with concrete crushing in the compression zone. As seen from the figure, failure of beam was not exactly symmetric on both sides of the middle column. In this case flexural action developed until the formation of plastic hinges at the middle joint. At this point, there was rapid yielding of the bottom beam reinforcement of the middle joint. Thereafter, yielding of the top beam rebars at the outer joints indicated the formation of the plastic hinge and that the full flexural capacity was reached. Flexural cracks were also observed in both the end columns,

whereas the columns were also found to have rotated at joint locations as a result of the large deformation of the middle column (Fig. 12(c)). This rotation of the columns indicated that the beam ends were not effectively restrained. Owing to this rotation, along with the limitation of actuator stroke and the discontinuity of beam members beyond the end columns, there was no development of the catenary action. As a result there was no further increase in load-carrying capacity of the frame. Catenary action is usually developed at a displacement of more than one-beam depth and it fully utilizes the reserve tensile strength of steel reinforcement. Since the displacement was limited to close to the beam depth there was no possibility of developing catenary action in this frame.

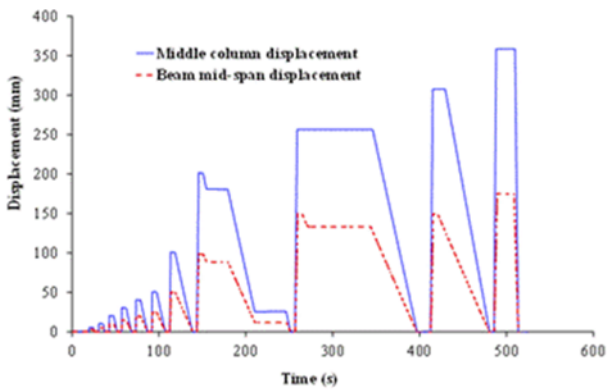
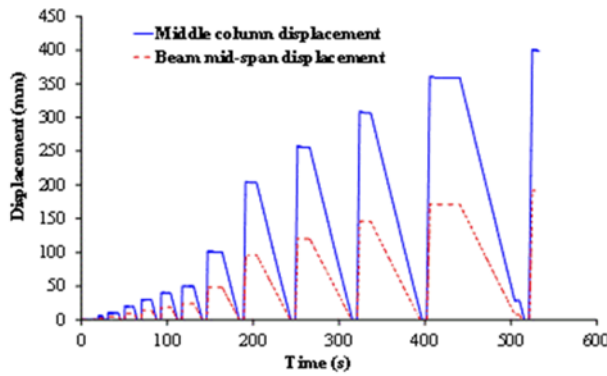
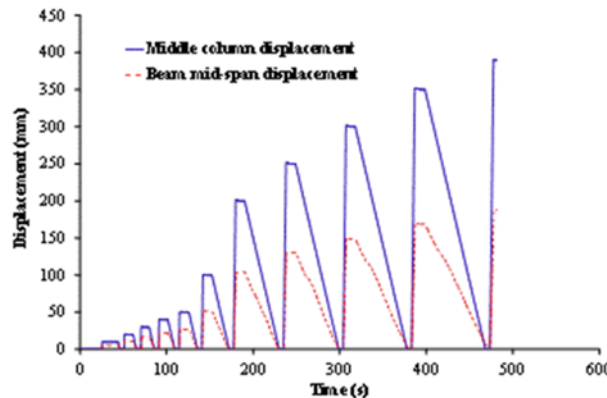
Fig. 13. Displacement-time History for: (a) Specimen PC-A, (b) Specimen PC-B, (c) Specimen MC-SMF

Displacement-time histories for middle column and the mid-span of the beam are shown in Fig. 13 for the three test specimens. As seen from the graph, for all target displacement levels, beam mid-span displacement of specimens PC-A and PC-B is about 46% of the middle column displacement thereby indicating expected hinge behavior of the frame. This behavior is confirmed from the theoretical beam-deformation mechanism depicted in Fig. 14(a), from which it can be inferred that the theoretical beam mid-span displacement equals 48% of the center column displacement. However, for monolithic specimen MC-SMF, beam mid-span displacement was about 55% of the middle column displacement up to a target displacement level of 50 mm

at the center column location, which indicates an elastic curve anticipated in continuous beams. This behavior is supported from the theoretical beam-deformation mechanism sketched in Fig. 14(b) for monolithic specimen with small middle column displacement. Yet, for middle column displacement levels more than 50 mm, the plastic hinge started to form at both beam ends and the beam turned into a hinge mechanism similar to that shown in Fig. 14(a), thus having a mid-span displacement of about 45% of the middle column displacement.

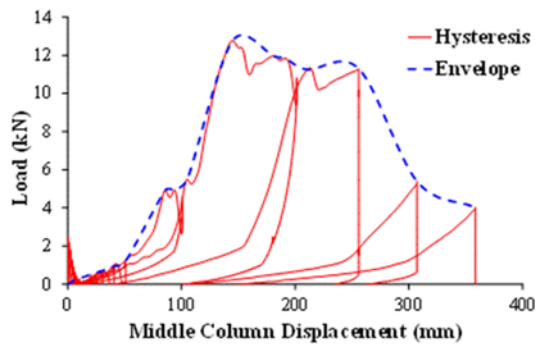
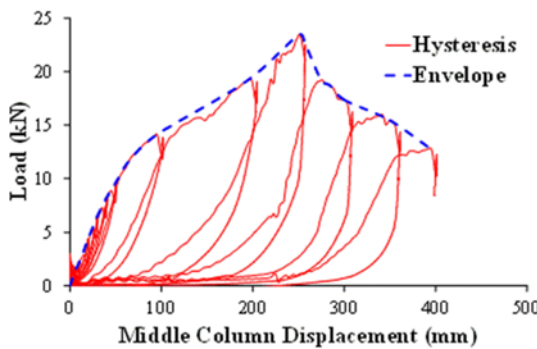
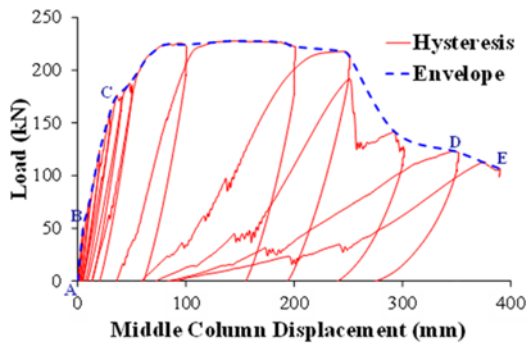
Fig. 15. Load-displacement Hysteresis for: (a) Specimen PC-A, (b) Specimen PC-B, (c) Specimen MC-SMF

Load versus middle column displacement hysteresis and envelopes are presented as shown in Fig. 15 for all test specimens.

The curves shown in Fig. 15 do not include the self-weight of the specimen. Comparison of load-displacement envelopes for test frames is shown in Fig. 16. Fig. 15(a) reveals that precast concrete buildings with connection type A is very vulnerable to progressive collapse once the supporting column is lost in an extreme event. The peak load (not including self-weight of frame specimen PC-A) was 12.8 kN. It was obtained in the 8th loading cycle corresponding to a target displacement of 200 mm. It is clear from Figs. 15 and 16 that the precast connection type B is better than connection type A in terms of its resistance to progressive collapse when subjected to sudden removal of column as a result of unexpected loading scenarios. For the precast specimen PC-B, the peak load (not including self-weight of the frame) was 23.5 kN. It was obtained in the 10th loading cycle corresponding to a target displacement of 300 mm as shown in Fig. 15(b).

For monolithic specimen MC-SMF, as seen in Figs. 15(c) and 16, the load-displacement envelope can be divided into four stages. The AB segment can be considered as the elastic stage, during which the relationship between the load and the vertical displacement of middle column is linear, without obvious

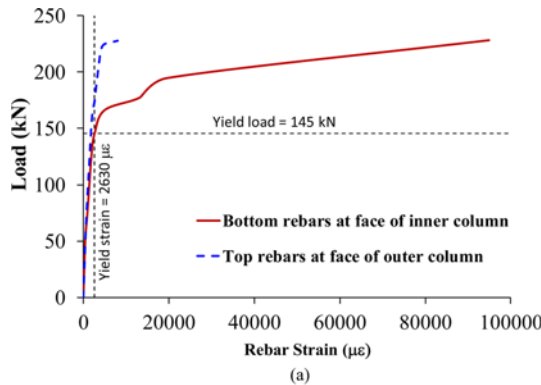
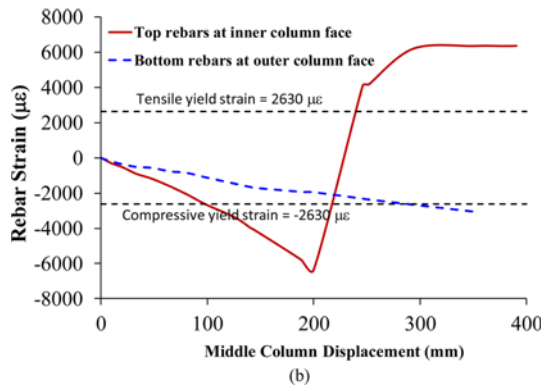
Fig. 17. Strain Gage Results for Longitudinal Beam Rebars of Specimen MC-SMF: (a) Longitudinal Tension Rebars, (b) Longitudinal Compression Rebars

Strain gage results for beam steel rebars of specimen MC-SMF are presented in Figs. 17(a) and 17(b) for tension and compression bars, respectively. As expected both the top (outer column face) and bottom (inner column face) rebars were in tension and were found to have exceeded the yield strength. As seen in Fig. 17(b), both the top (inner column face) and bottom (outer column face)

steel rebars of the beam were in compression until a displacement of 200 mm, after which the top rebars at the middle joint went from compression to tension and then yielded in tension. This indicated that until 200 mm of displacement, the flexural cracks had still not reached the top rebars whereas as the displacement increased above 200 mm, the flexural cracks penetrated the beam depth and reached the top rebars thereby applying tensile stresses on the top rebars at inner column face.

From Fig. 17(b), it is clear that all beam rebars were not in tension, which prevented the full formation of catenary action. This can be attributed to the limitation of the actuator stroke, which in turn limited the middle column displacement to 400 mm and also indicates the insufficient restraint provided by the outer columns. The beam-column joints could not provide enough anchorage for longitudinal steel rebars at the beam ends, which directly affected the development of the catenary forces. The research results of Yi *et al.* (2008) and Yu and Tan (2013) showed that the bearing capacities of the catenary action stage generally exceed that of flexural capacity of frame beam. In another study, Wang *et al.* (2016) observed that the damage of beam-column joints limits the development of the catenary action when the joints are damaged before the frame beam. Thus,

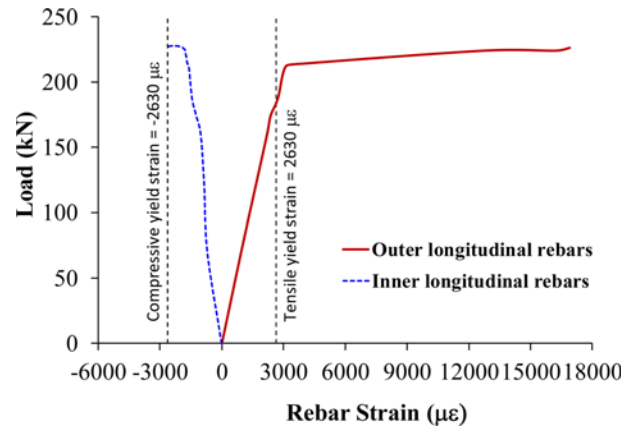
Fig. 18. Strain Gage Results for Longitudinal Column Rebars of Specimen MC-SMF

Figure 18 shows load versus steel strain of longitudinal rebars of outer columns. Strains in both inner and outer column rebars are depicted in the figure. As seen from the figure, the outer longitudinal rebars are in tension and have yielded whereas, the inner column rebars are in compression and have also yielded. This indicates flexural bending of the outer columns.
