Textile-Reinforced Mortar versus FRP as Strengthening Material for Seismically Deficient RC Beam-Column Joints

Abstract: In this paper, efficiency and effectiveness of textile-reinforced mortars (TRM) on upgrading the shear strength and ductility of a seismically deficient exterior beam-column joint has been studied. The results are then compared with that of carbon fiber-reinforced polymer (CFRP) and glass fiber-reinforced polymer (GFRP)-strengthened joint specimens. Five as-built joint specimens were constructed with non-optimal design parameters (inadequate joint shear strength with no transverse reinforcement) representing an extreme case of pre-seismic code design construction practice of joints and encompassing the vast majority of existing beam-column connections. Out of these five as-built specimens, two specimens were used as baseline specimens (control specimens) and the other three were strengthened with TRM, CFRP, and GFRP sheets, respectively. All five subassemblages were subjected to quasi-static cyclic lateral load histories to provide the equivalent of severe earthquake damage. The response histories of control and strengthened specimens were then compared. The tes

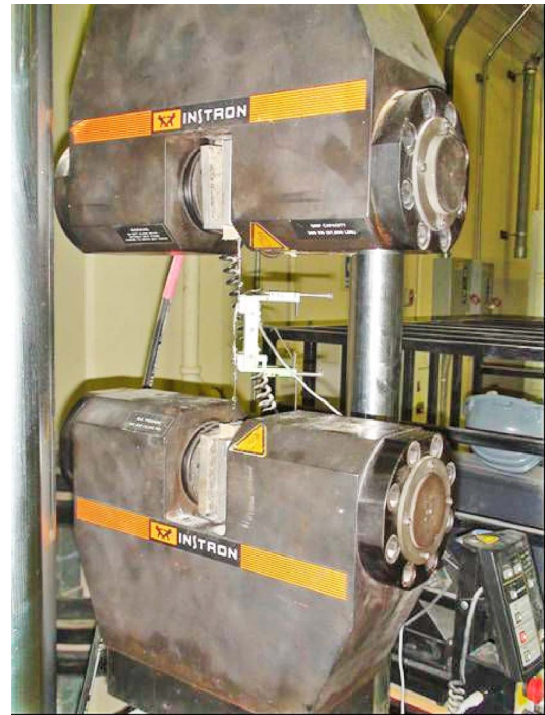
**Fig. 4.** Textile coupon under test (image by the authors)

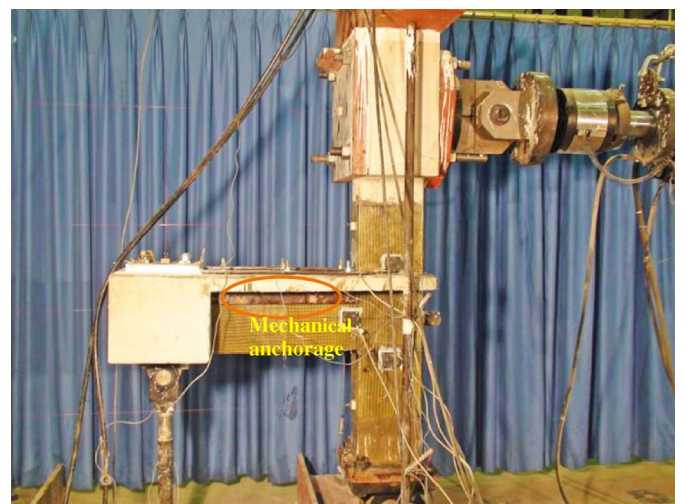
Fig. 8. Photo showing GFRP scheme applied to as-built exterior joint (image by the authors)

specimen (Fig. 7), the mechanical anchorage system was not used because debonding was not expected in this specimen because of the strong bond between CFRP sheets and the concrete surface. Figs. 6 and 7 illustrate the GFRP and CFRP schemes applied to as-built joint specimens.

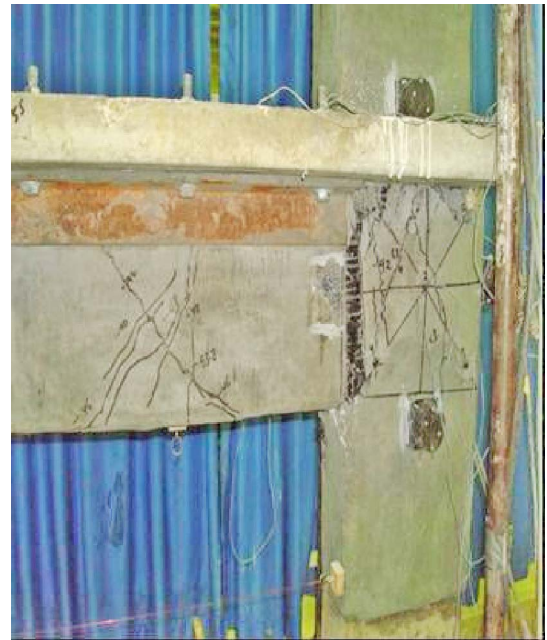
Fig. 18. Failure pattern of TRM-strengthened specimen (image by the authors)

specimens. This indicates the delay of shear cracks by using TRM-strengthening. At about 40 mm displacement, the excessive shear cracks were seen in the joint region, and the load reached its peak value (53 kN). The load started dropping down after this displacement, indicating sufficient degradation of stiffness of the specimen. At approximately a 20% drop in the peak lateral load, the specimen showed substantial cracks in the joint, at the beam-joint interface and at the interface of slab and columns (Fig. 18). The fracture of the textile fibers was also observed at higher stages of loading. The fibers started breaking near the bottom of the beam-column joint interface at higher stages of loading. The fracture of fibers continued in a vertical upward direction until the last textile fiber was broken.

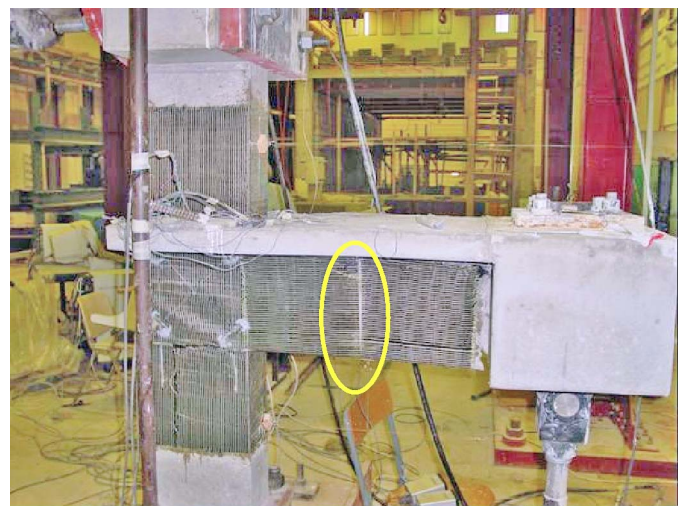
Fig. 19. Failure pattern of CFRP-strengthened specimen (image by the authors)

The CFRP-strengthened specimen showed a similar behavior to the one mentioned in Al-Salloum et al. (2011). As debonding was not prevented, the failure was primarily because of debonding of

CFRP sheets in the beam region. Tearing of the CFRP sheet was also observed in the beam region because of the fact that at higher stages of loading, there was significant yielding in beam reinforcing bars that allowed cracks to widen in the beam region, which in turn ultimately tore the CFRP sheets (Fig. 19). In the case of GFRP strengthening, debonding was not observed because the sheets were prevented against debonding through a mechanical anchorage system. Because of the prevention of debonding, at higher stages of loading, tearing of GFRP sheets was observed (Fig. 20). The number of layers used in GFRP strengthening was two, whereas number of layers in CFRP-strengthening was only one. It is for reason that similar peak loads were observed with GFRP and CFRP strengthening.

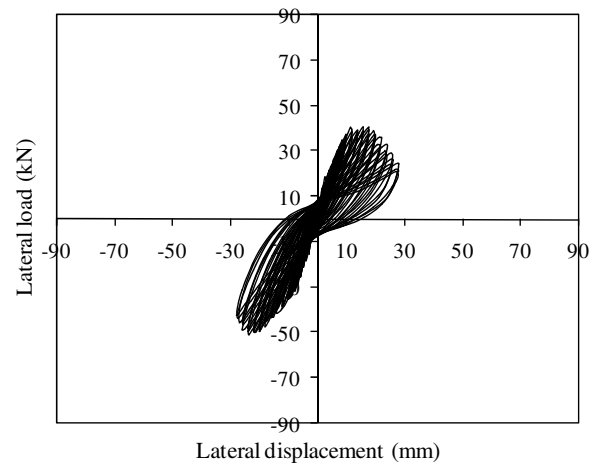
Fig. 22. Load-displacement hysteretic curves for as-built control specimen (ECON2)

The hysteretic behavior of exterior joints was examined in terms of shear strength (measured in ultimate load) and deformation capacity. The load-displacement relationships for control and strengthened specimens are shown as hysteretic curves in Figs. 21–25. Figs. 21 and 22 show that for control specimens, deformability is very poor as specimens reach to their ultimate load at a displacement of 26 mm. On the other hand, CFRP strengthening provides a higher load-carrying capacity than control, GFRP-strengthened, and TRM-strengthened specimens. However, deformability of CFRP strengthening is not as good as GFRP or TRM strengthening (Figs. 23 and 24). This suggests that the use of TRM and GFRP is preferable over CFRP strengthening under seismic excitations because of better deformability of GFRP- and TRM-strengthened joints. Deformability and ductility are important requirements for RC structural components to survive during seismic excitations. The ultimate load for strengthened specimens is higher than control specimens. This is primarily because of the increased confinement of the joint, resulting from externally bonded FRP sheets or a TRM textile system. Also, the hysteretic loops of specimens showed considerable pinching and continuous stiffness degradation with increasing displacement. The loss of stiffness was primarily

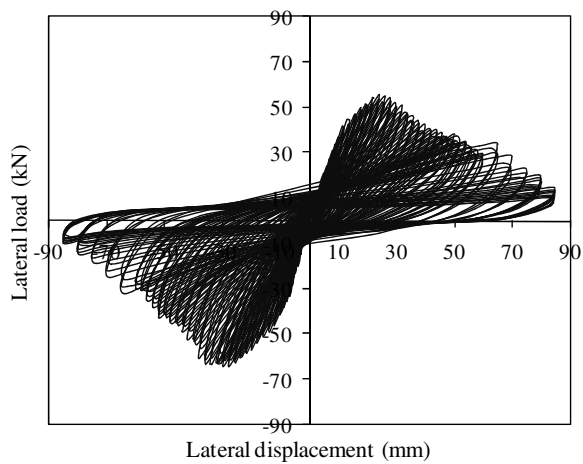
Fig. 24. Load-displacement hysteretic curves for GFRP-strengthened specimen (EGFRP)

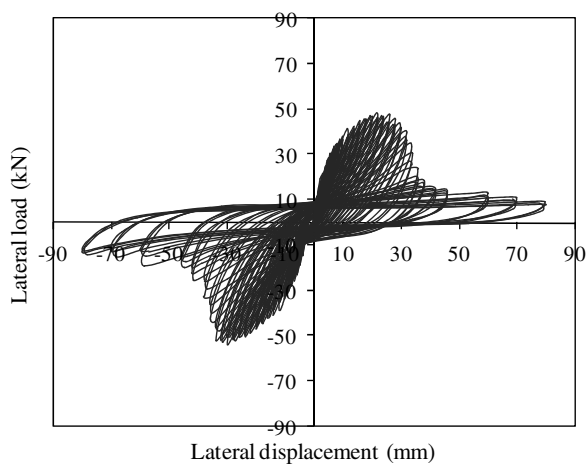
Fig. 25. Load-displacement hysteretic curves for TRM-strengthened specimen (ETRM)

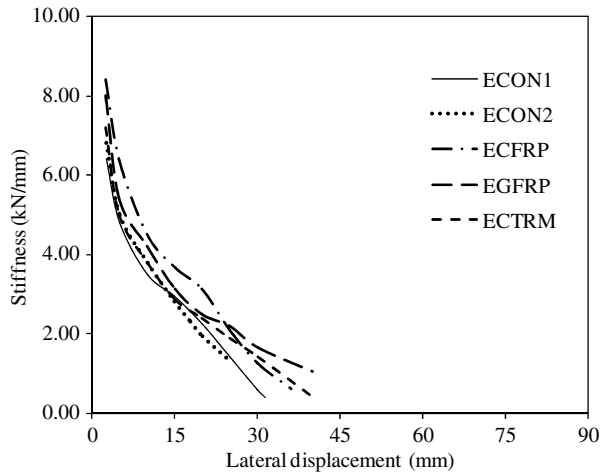
**Fig. 27.** Stiffness degradation in as-built control and strengthened specimens

The beam-column joint stiffness was approximated as the slope of the peak-to-peak line in each loop. Fig. 27 shows the stiffness degradation with lateral displacement. This degradation may be attributed to concrete nonlinear deformations, flexural and shear cracking, distortion of the joint panel, slippage of reinforcement, loss of cover, and debonding or delamination of FRP. A comparison of the strengthened specimens curve with the corresponding control specimen curve shows that the initial stiffness of the strengthened specimens are significantly higher than that of their corresponding control specimen. This higher initial stiffness for the strengthened specimen may be attributed to the external bonding of FRP sheets or TRM layers on beams, joint, and column regions. The use of FRP or TRM shows that the degradation in the stiffness is slow compared to control specimens. The slow degradation is a desirable property in earthquake-like situations. It was observed in the past earthquakes that most of the RC structures failed (or collapsed) because of a sudden loss of stiffness of the structural joints with increasing lateral movement of the structure.
